PRELIMINARY REPORT

INVESTIGATION INTO SERIOUS INCIDENT OF ATR 72-500 AIRCRAFT REG NO S2-AHF OF NOVOAIR OCCURRED ON 17 NOVEMBER 2021 AT VGSD AIRPORT, SAIDPUR, BANGLADESH

Preliminary Report of Investigation into Serious Incident of ATR 72-500 Aircraft, Reg No S2-AHF of NOVOAIR that Occurred on 17 November 2021 at VGSD Airport, Saidpur, Bangladesh

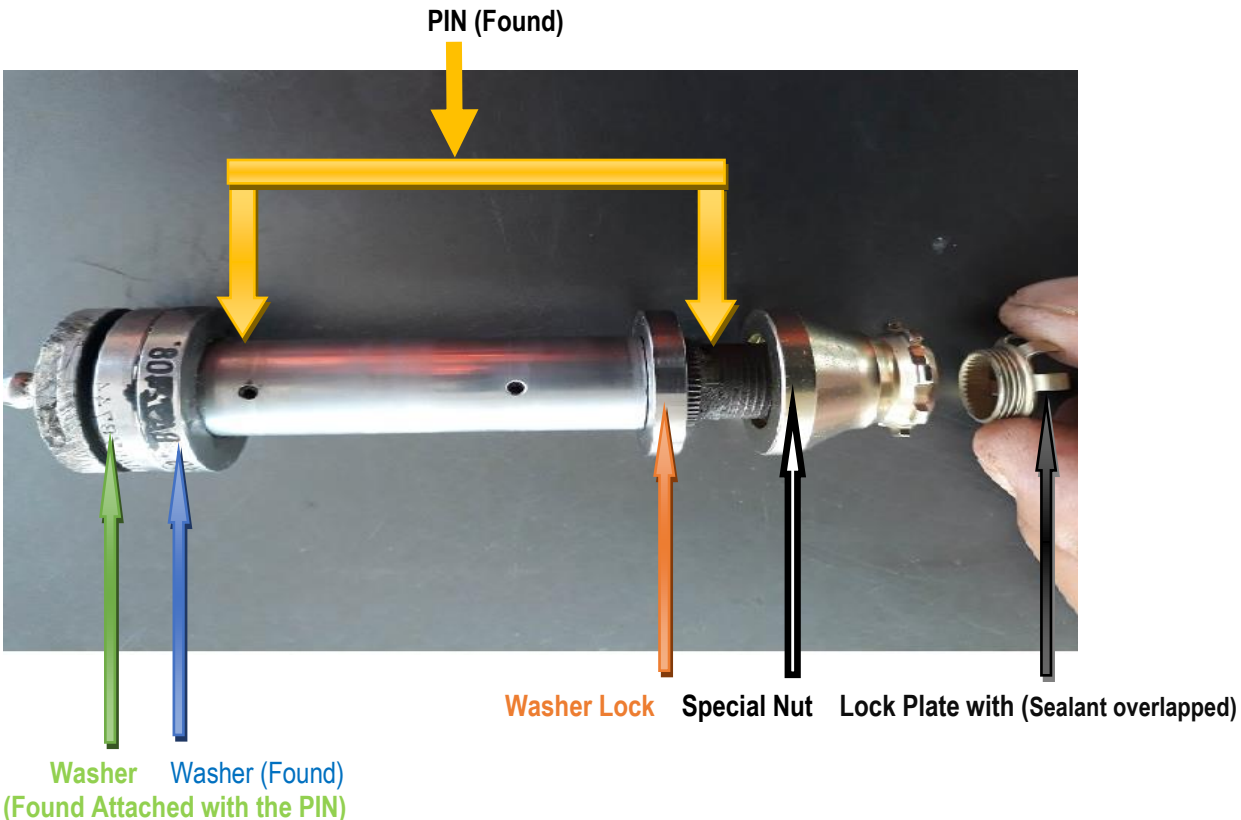
The '**PIN**' (Part No D64724) is locked by a '**LOCK PLATE**' (Part No. SL61WTM12P), with '**SEALANT**' (Part No. PR1826A2) overlapped, a '**SPECIAL NUT**' (Part No. SL40358P), **WASHER-LOCK**' (Part No. SL 40359), **WASHER** (Part No. D49691) and another **WASHER** (Part No. D56860).

PIN (Found)

Washer Lock Special Nut Lock Plate with (Sealant overlapped)

Washer Washer (Found)
(Found Attached with the PIN)

<p>C. 'PIN' (Part No D64724) with 'WASHER' (Part No. D49691) which was found on the right shoulder of the runway is locked by 'LOCK PLATE' (Part No. SL61WTM12P, missing) with 'SEALANT' (Part No. PR1826A2, missing) overlapped. After 'LOCK PLATE' there is a 'SPECIAL NUT' (Part No. SL40358P, missing) which holds the 'PIN'. After the 'SPECIAL NUT' there is a 'WASHER-LOCK' (Part No.SL 40359, missing) which also restricts the movement of 'PIN'. After 'WASHER LOCK' there are two more 'WASHER' (Part No. D56860, which was found on the center line of the runway), and another 'WASHER' (Part No. D49692, missing).</p>	NIL
3.1.3.3 Slightly damaged	NIL

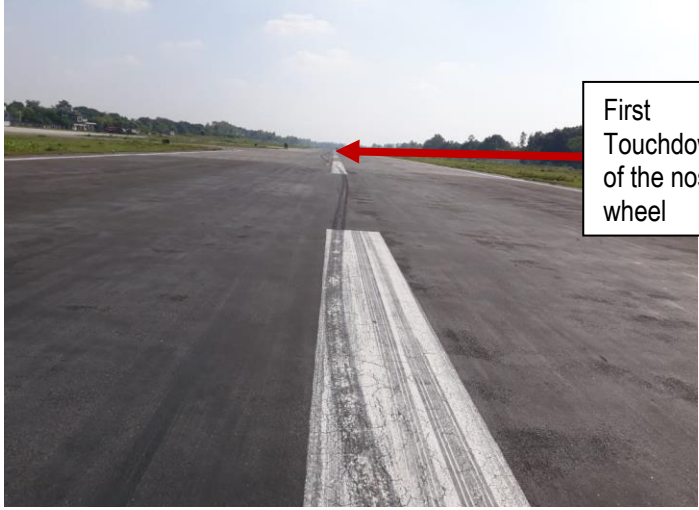
<p>First Touchdown of the nose wheel</p> <p>First touchdown of nose landing gear. (The photograph is taken from the opposite direction of the landing aircraft for better visibility)</p>

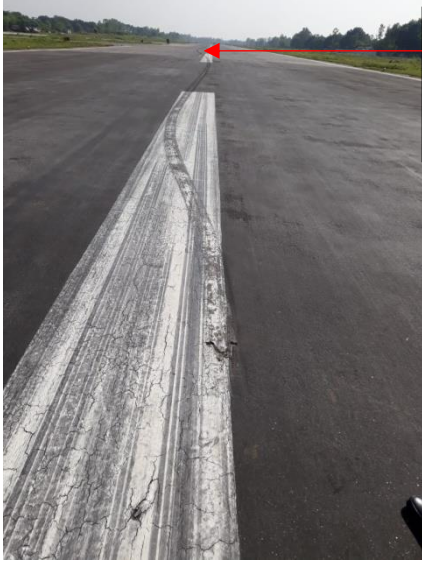
<p>Went to the right after touchdown</p> <p>(The photograph is taken from the opposite direction of the landing aircraft for better visibility)</p>
---	---

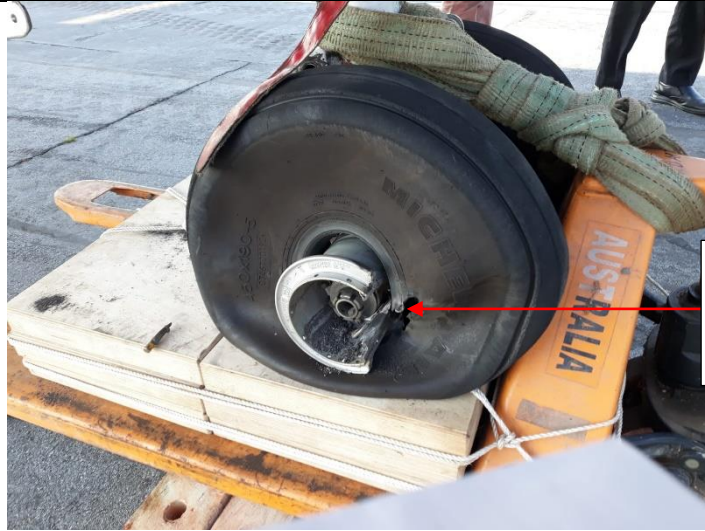
Nose Tyre -
Ruptured
and flattened

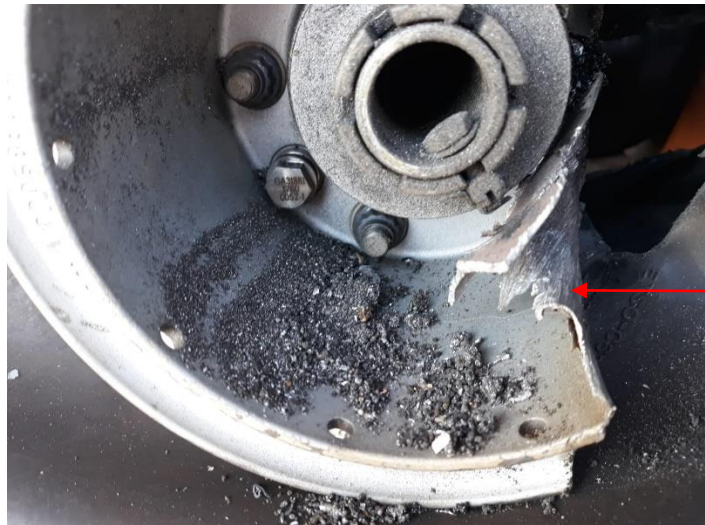
Severely
damaged
nose
wheel

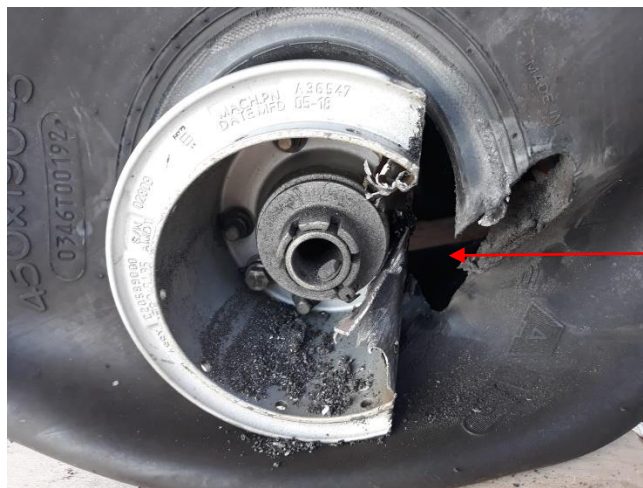
Severely
damaged
nose
wheel tyre and
drum

3.1.14.1 If fire occurred, information on the nature of the occurrence, and of the firefighting equipment used and its effectiveness	Several sparks were observed due to nose wheel drum friction on the runway which was reported by Air Traffic Controller. Fire fighting equipment was not used.
--	--
