FINAL REPORT

Investigation into Accident of Cessna-152 Aircraft, Reg No S2-AGG of Bangladesh Flying Academy & General Aviation Ltd. Occurred on 16 March 2021 at Lalpur, 11 NM North West of VGRJ Airport, Rajshahi, Bangladesh

REF. NO. 30.00.0000.013.33.006.21 (CESSNA-152/S2-AGG/ 16 MAR 2021)-121		14 March 2022

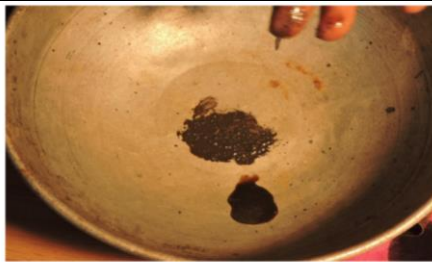
Photograph 1: Metal Chips of residual oil in sump

- a. The team cut the locking wire and opened the lock nut, took the sample of residual oil from the sump; checked for metal contamination, found lot of tiny metal chips in the residual oil. (Photograph 1)
- b. Removed the oil screen from the sump and checked for metal chips; found approximately 0.8 mm size metal chip on the screen. (Photograph 2)
