FINAL REPORT

INVESTIGATION INTO INCIDENT OF DHC-8 SERIES-400 AIRCRAFT REG NO S2-AJW
OF BIMAN BANGLADESH AIRLINES OCCURRED ON 16 MAY 2025 AT VGCB, COX'S BAZAR AIRPORT
BANGLADESH.

**PUBLISHED BY
THE OFFICE OF THE AIRCRAFT ACCIDENT AND SERIOUS INCIDENT INVESTIGATION COMMITTEE OF
BANGLADESH**

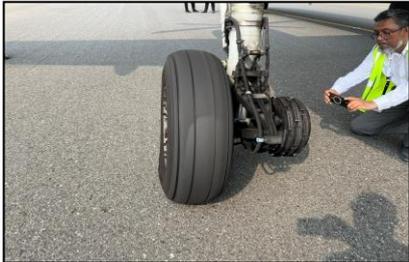
<p>Figure 3: Missing wheel area.</p>

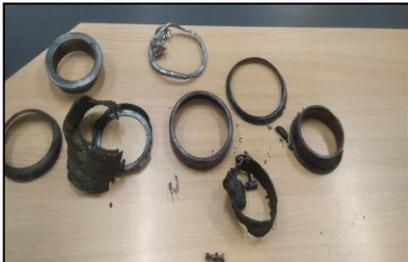
<p>Figure 4: Damaged parts of the detached wheel.</p>

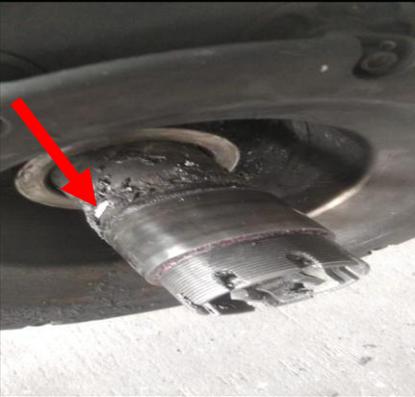
<p>Figure 5: Carbon deposit on axle</p>

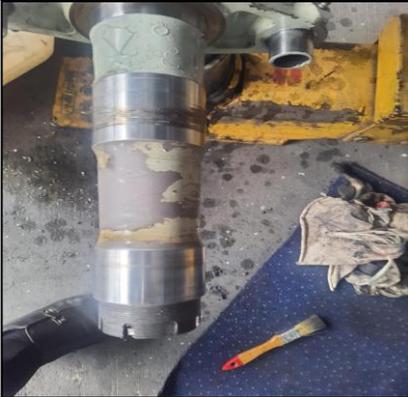
<p>Figure 6: Damaged axle</p>

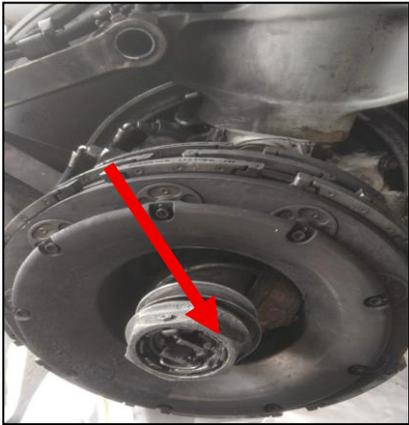
<p>Figure 7: Axle Nut</p>

3.2.1.7 During inspection it was found that axle nut was damaged, which is indicative of wheel bearing failure (rounded corners). This damage also indicates the axle nut was present at the time of bearing failure and wheel departure.

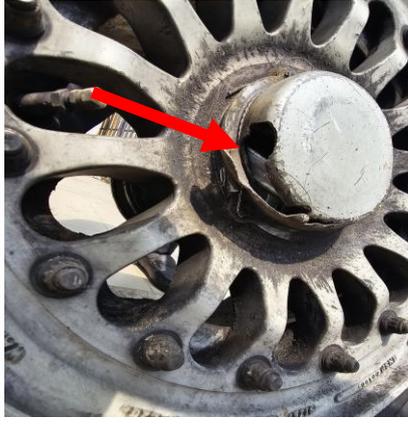
<p>Figure 8: Damaged Outer Wheel with protective cover</p>

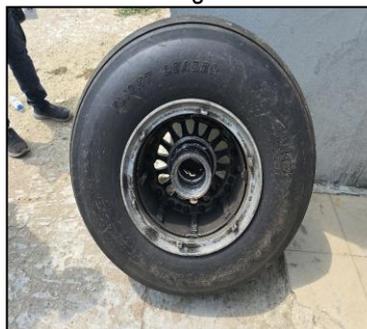
Figure 2: Wheel from Position #2

The wheel's inboard bearing cup is completely absent from the wheel half and there is substantial damage to the wheel hub in the area of the bearing cup, Figure 2 and Figure 3. This suggests an inboard bearing structural failure.

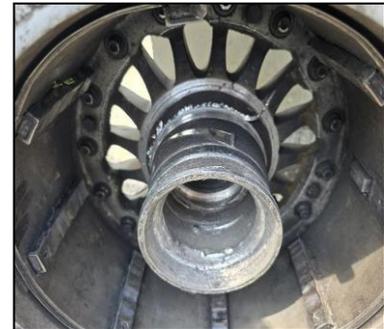
Figure 3: Wheel #2, Loss of Inboard Bearing and Hub Damage

- Improper setting of the axle nut. A loose operating setting can result in improper roller contact with the cage resulting in rapid cage wear. The rollers can subsequently trap the cage on the cup race resulting in the cage rupture and / or lockup of the rollers within the bearing cone.

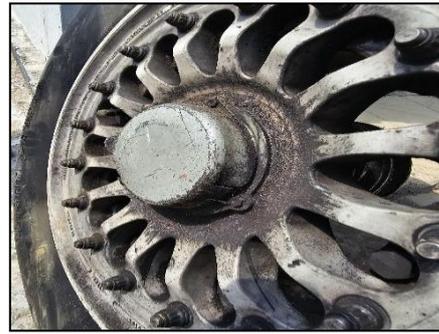
Figure 4: Wheel #2, Outboard Wheel Half

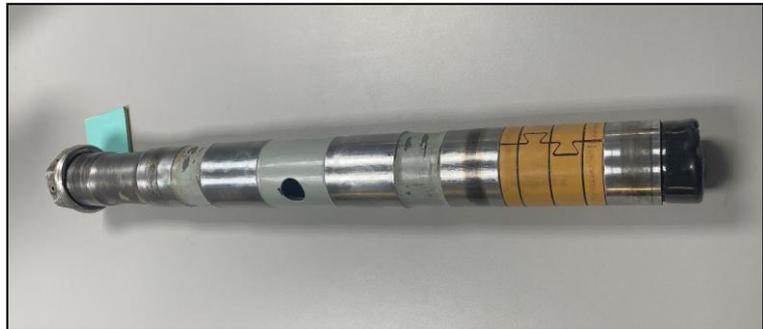
Figure 5: Axle, Removed from Aircraft Wheel Position #2 (Left)

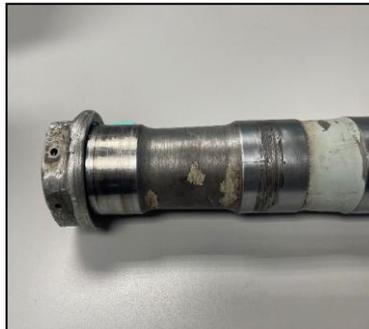
Figure 6: Axle, Wheel Position #2

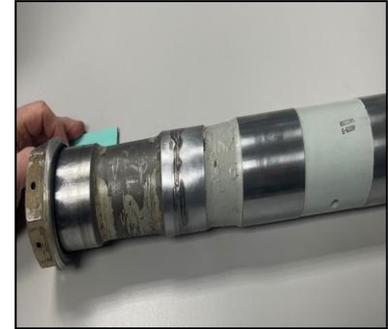
Figure 7: Axle, Wheel Position #2
