REF. NO. 30.00.0000.013.33.001.25/27 (Airbus A330-300 Reg HS-TEW / 29 Oct 2025)

DATE OF RELEASE: 20 November 2025

## PRELIMINARY REPORT

### INVESTIGATION INTO SERIOUS INCIDENT OF AIRBUS A330-300 AIRCRAFT, REG NO HS-TEW OF THAI AIRWAYS INTERNATIONAL OCCURRED ON 29 OCTOBER 2025 AT VGHS, DHAKA, BANGLADESH

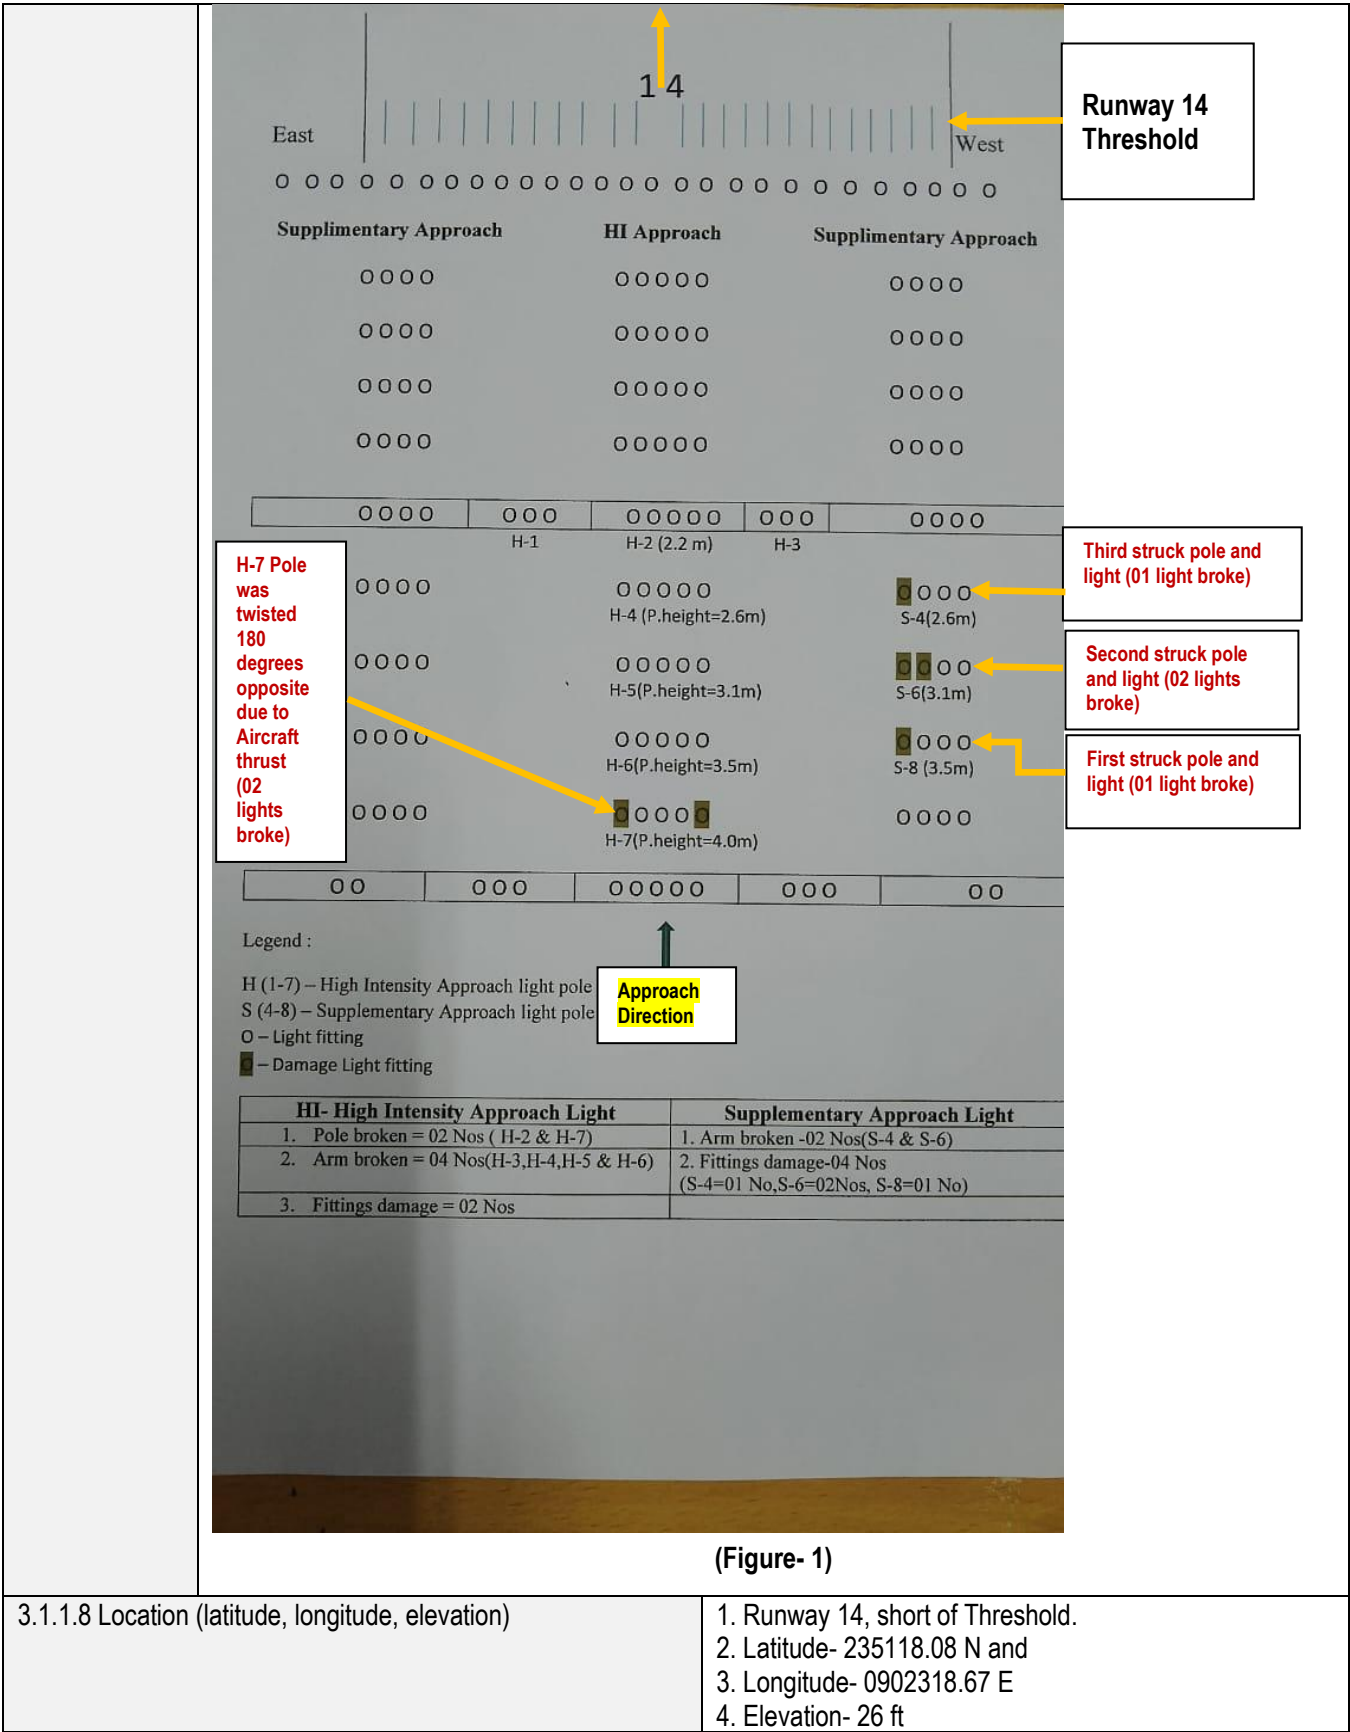
3.1.1.5 Point of intended landing	VGHS (Dhaka)
3.1.1.6 'Flight preparation'	Flight preparation was satisfactory.
3.1.1.7 Description of the flight and events leading to the accident, including reconstruction of the significant portion of the flight path, if appropriate.	<p>On 29 October 2025, at 0730 UTC, the Head of the AASIIC-BD received a telephone call from Executive Director, HSIA that at around 0613 UTC, while approaching runway-14, one Airbus A330-300, Reg Number HS-TEW of Thai Airways struck with a section of the Precision Approach Lights and its supporting poles. The aircraft immediately executed go around. At 0656 UTC, the aircraft approached on runway-32 (reciprocal) and landed safely.</p> <p>During post-flight, it was revealed that the aircraft's (Airbus A330-300 of Thai Airways), No. 4 tyre (Rear inner tyre) of the left main landing gear was damaged. The tyre surface exhibited damage in two distinct areas.</p> <p>On the other hand, the struck of aircraft on final approach runway-14 (Airbus A330-300 of Thai Airways), resulted damage/ breaking of several Precision Approach lights and poles. The <b>Supplementary</b> Approach poles and lights <b>S-8</b> struck first, subsequently <b>S-6</b> and <b>S-4</b> poles and lights were struck (as of now total six lights). All the broken lights travelled along the flight direction towards the threshold. Total 09 poles and 06 lights were damaged/ broken. (<b>Figure- 1</b>)</p>

3.1.4.1 Other Damage	<b>HI- High Intensity Approach Light</b> <ol style="list-style-type: none"> <li>Pole broken = 02 No (H-2 &amp; H-7)</li> <li>Arm broken = 04 No (H-3, H-4, H-5 &amp; H-6)</li> <li>Fittings damage = 02 Nos</li> </ol>	<b>Supplementary Approach Light</b> <ol style="list-style-type: none"> <li>Arm broken -02 No (S-4 &amp; S-6)</li> <li>Fittings damage-04 Nos (S-4=01 No,S-6=02Nos, S-8=01 No)</li> </ol>
	Figure - 1

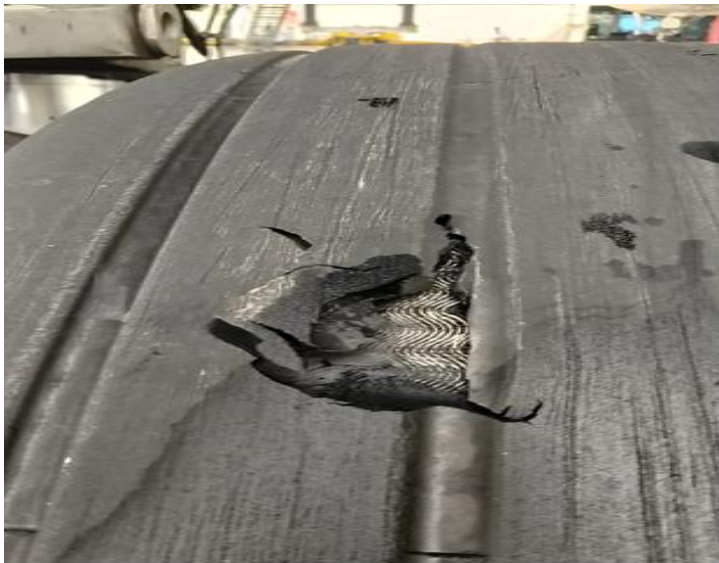
<p><b>Figure - 2</b></p>

3.1.3.1 Destroyed	No
3.1.3.2 Substantially damaged	<p>Aircraft's (Airbus A330-300 of Thai Airways), No. 4 tyre (Rear inner tyre) of the left main landing gear was substantially damaged. The tyre surface exhibited damage in two distinct areas. <b>Figure - 2, 3, 4 and 5</b></p> <div style="text-align: center;">

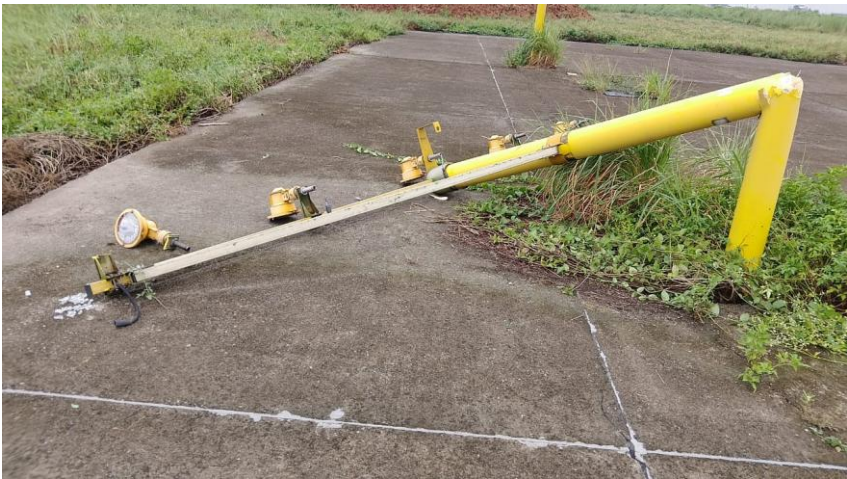
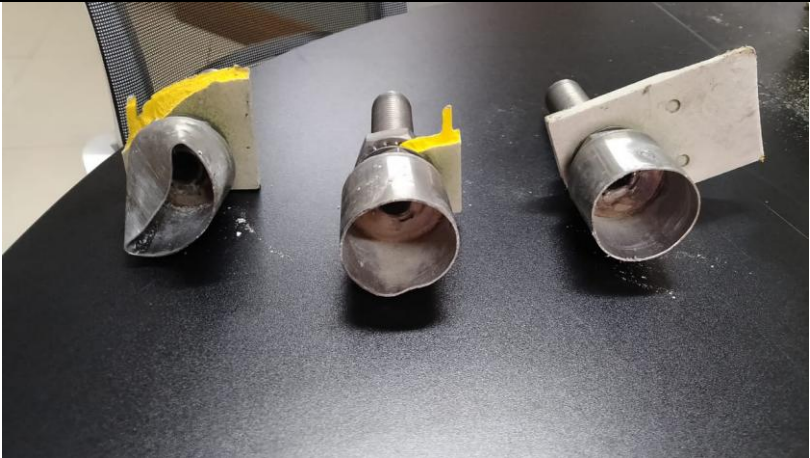
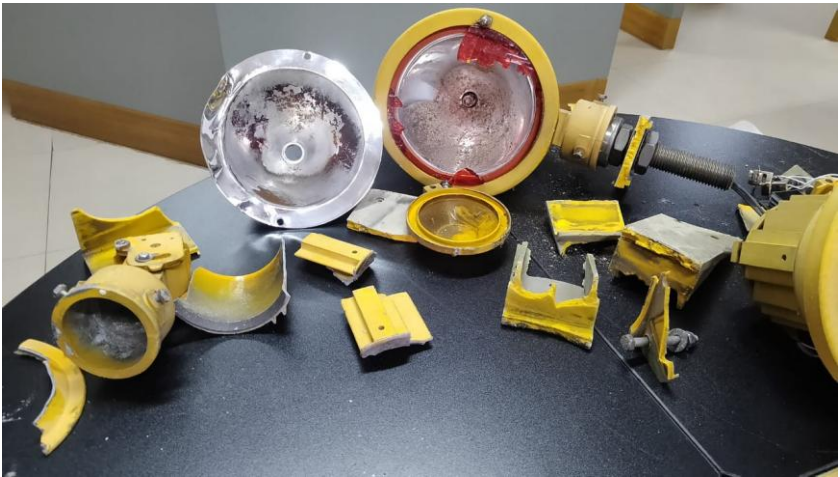
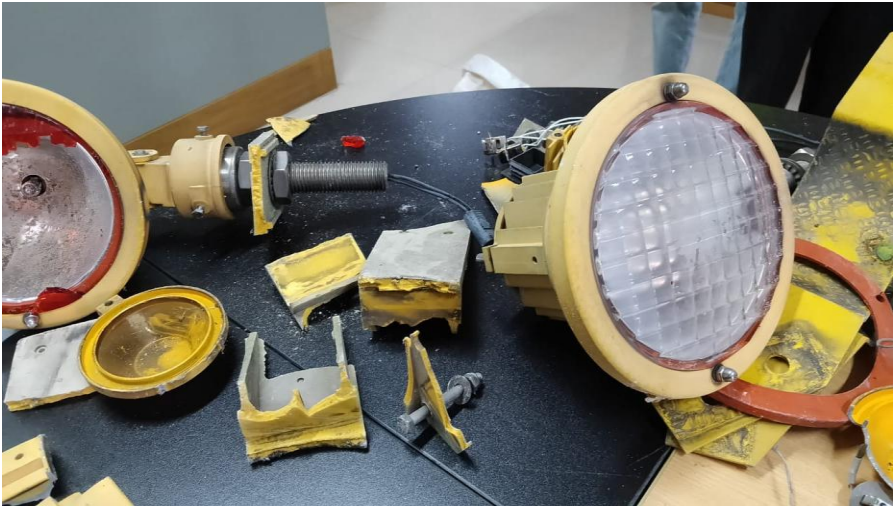
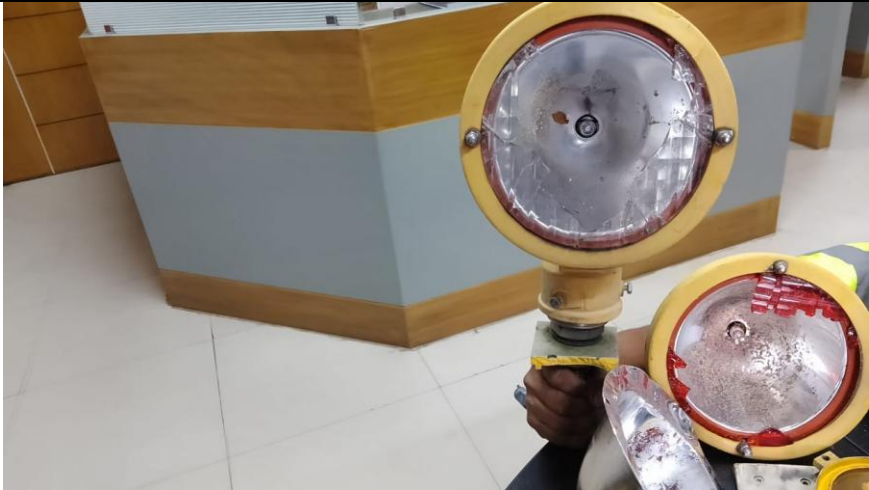
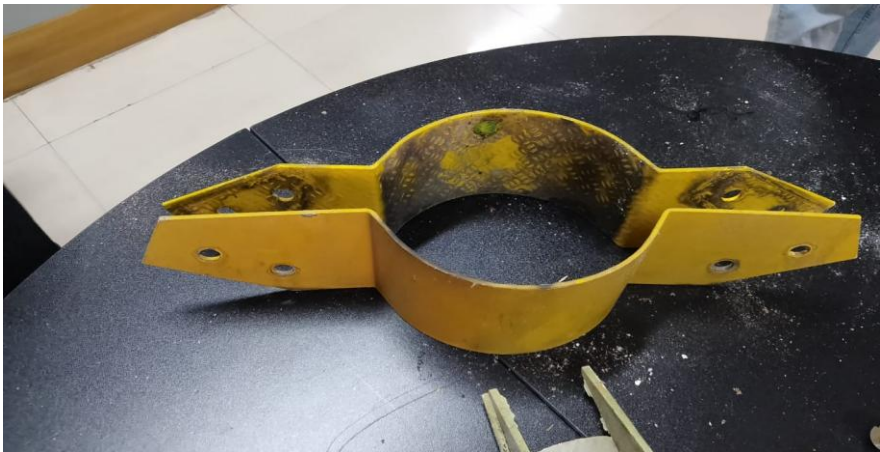
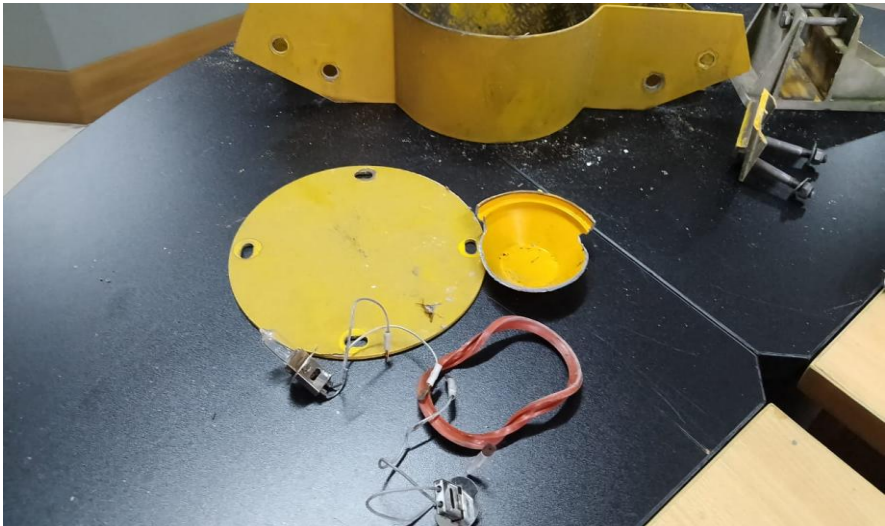
<p>3.1.12.1 General information on the site of the accident and the distribution pattern of the wreckage, detected material failures or component malfunctions. Details concerning the location and state of the different pieces of the wreckage are not normally required unless it is necessary to indicate a break-up of the aircraft prior to impact. Diagrams, charts and photographs may be included in this section or attached in the</p>

3.3.1.1 Findings	<p><b>Findings</b> During the final of approach on runway 14, the Airbus 330-300 of Thai Airways struck the lights of Precision approach Lighting System breaking total of 06 Precision approach Lights.</p> <ol style="list-style-type: none"> <li>1. The first struck was at the S-8 (Supplementary pole-8) extreme left one light broke. The broken light moved along the flight path/ direction by 100 meters approximately towards the threshold. (The whole assembly of the light was found along the flight path/ direction by 100 Meters approximately)</li> <li>2. Second hit was at the S-6 extreme two left light (Supplementary pole Light-6) of the Precision approach and two lights broke. The broken lights moved along the flight path/ direction by 70-80 meters approximately towards the threshold. (The whole assembly of the lights were found along the flight path/ direction by 70-80 Meters approximately)</li> <li>3. The third hit was at the S-4 extreme left one light (Supplementary pole Light-4) of the Precision approach light broke. The broken light moved along the flight path/ direction by 50 -60 meter approximately towards the threshold. (The whole assembly of the light was found along the flight path/ direction by 50-60 Meters approximately)</li> <li>4. About more two lights which were installed at H-7 (High intensity light pole -7). This pole was twisted 180 degrees opposite and broke because of the jet blast (ac opened power and went round). These two lights broke with the fall of the pole on the ground.</li> </ol> <p>As regards to the poles, total 09 poles damaged/ broke where 02 poles (H-2 and H-7) totally broken with jet blast.</p> <ol style="list-style-type: none"> <li>1. H-2 (High intensity Light Pole, height is 7 ft) which is installed at 150 meter short of the threshold and twisted 180 degrees opposite with the Jet Blast.</li> <li>2. H-7 (High intensity Light Pole-7, Pole height is 13 ft) which is within 300 meter short of the threshold and twisted 180 degrees opposite with the Jet Blast.</li> </ol> <p>Aircraft's (Airbus A330-300 of Thai Airways), No. 4 tyre (Rear inner tyre) of the left main landing gear was substantially damaged. The tyre surface exhibited damage in two distinct areas.</p>
