### FINAL INVESTIGATION REPORT OF B-777 RUNWAY EXCURSION AT VGHS DHAKA BANGLADESH ON 24-07-2018

#### **Investigation into the Serious Incident of B-777 Aircraft, Nationality and Registration Mark HS-TJD of Thai Airways International Public Company Ltd on 24 July 2018 at Hazrat Shah Jalal International Airport, Dhaka, Bangladesh**

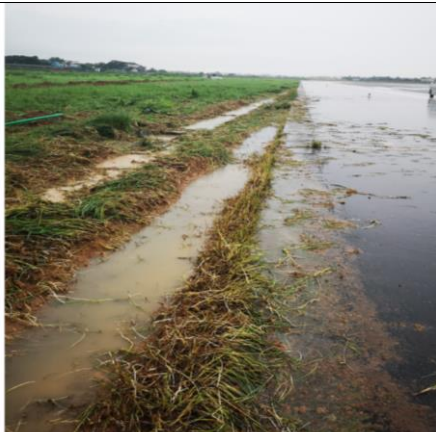
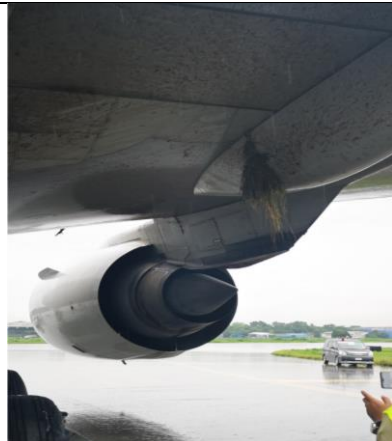
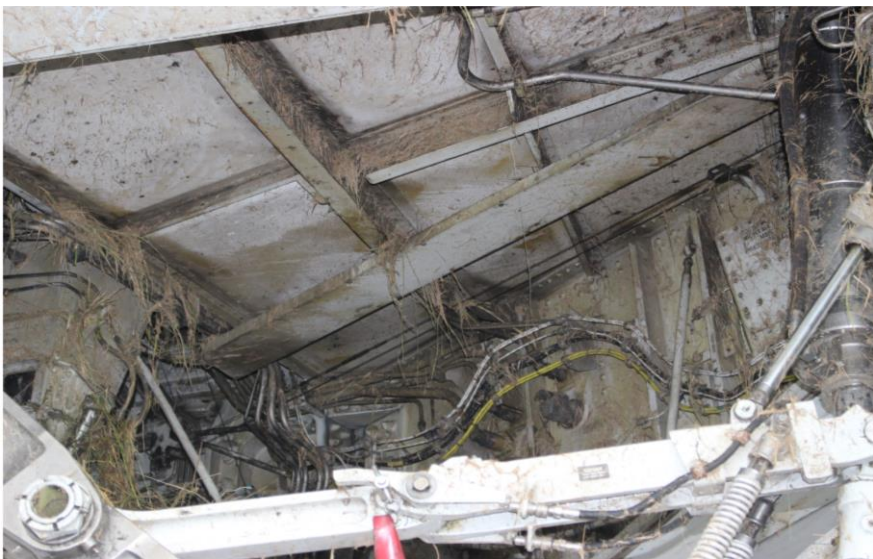
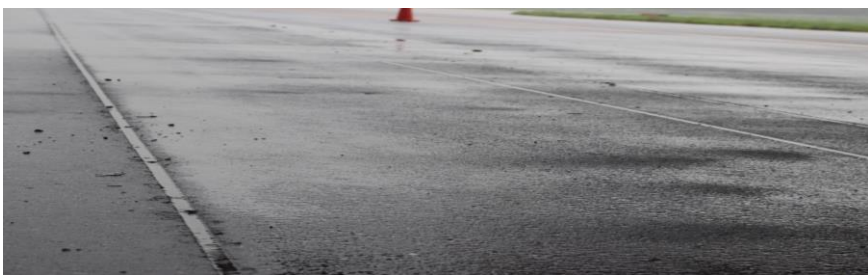
3.3.2	Substantially damaged	<p>a) All the six tyres of the right main landing gear were found partially and/or completely torn and damaged with wheel hubs broken and exposed with entire wheel-well having grass-mud deposition.</p> <p>b) Brake assemblies of a few wheels of the right main landing gear appeared to be torn, damaged and cables are detached from the wheel assembly.</p> <p>c) Minor bent to some degrees of the right inner flap of the aircraft was found with grassy mud deposition around the flap hinges.</p> <p>d) Grassy mud was also observed inside the right engine exhaust areas of the aircraft.</p> <div data-bbox="603 784 1471 1153"> </div> <div data-bbox="603 1187 1492 1601"> </div>
-------	-----------------------	--

3.3.3	Slightly damaged	No
3.3.4	Other damage	<p>a) About nine wiring concrete pits of about 5 feet (length) x 4 feet (width) x 2 feet (depth) dimension, lying along the RWY right edge in the grassy mud area, were partially or largely broken and damaged;</p> <p>b) The exposed rims of the broken Tires cut through about 5000 Feet of the RWY surface with 2 Inch X ½ Inch marks.</p>

**b) Radar Equipment at HSIA:** Radar Service of HSIA should be upgraded so that the Radar equipment can show the weather phenomenon around for aircraft vectoring by the approach controllers during weather conditions;**c) Maintenance:** The reliability program of the operator should monitor the in-service reliability of the Retread Aircraft Tires.**d) Aerodrome Operator of HSIA:** The aerodrome operator should consider locating and designing drains or any other underground electrical systems installation particularly for those to be installed with concrete encasement, manholes and handholds by chambering or tapering design of the edge of those and/or locating those as far as practicable from the edge of runway.**11. APPENDICES**

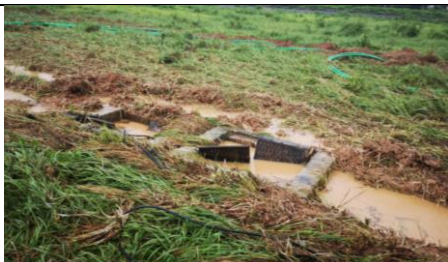
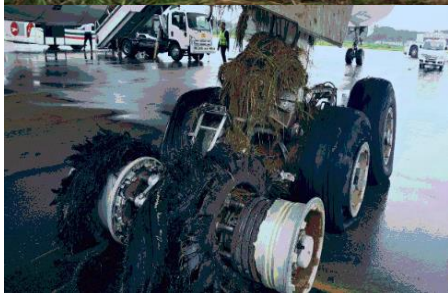
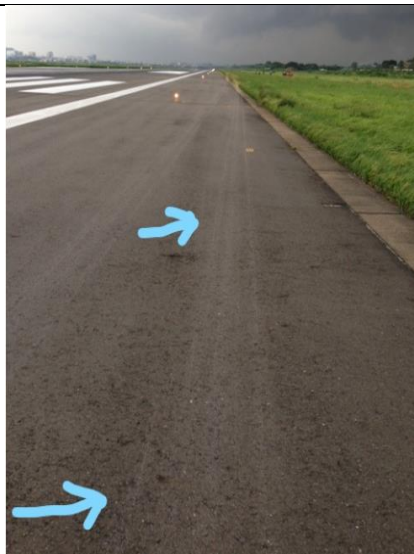
Para	Heading	Description
3.11.1	General information on the site of the accident and the distribution pattern of the wreckage, detected material failures or component malfunctions. Details concerning the location and state of the different pieces of	The AAIT believes that the aircraft touched down short of the RWY Touch Down Zone and on to the right half of the RWY centerline. According to the photographic evidence, indicated underneath, the right outbound rear wheel might have burst immediately after the touched down and on impact with the RWY surface. This might have made a tendency for the aircraft to veer slightly to the right resulting the right wheel assembly to go outside the RWY edge into wet grassy mud. None the less, it cannot be ruled out that the huge mass of the aircraft which veered slight right into the wind near the threshold might have brought-in inertial force resulting the aircraft to veer further right into the grassy area. According to the DFDR read out, the PIC applied the left rudder immediately after touch down to bring the aircraft back to centerline. While the aircraft continued to roll with its right wheels on the muddy surface, the wheels went over about nine (09) concrete cubical pits of about 5 feet (length) x 4 feet (width) x 2 feet (depth) dimension, that resulted the rupturing and bursting of at least four of the six wheels of the right landing gear.
