PRELIMINARY REPORT

INVESTIGATION INTO INCIDENT OF DHC-8 SERIES-400 AIRCRAFT REG NO S2-AJW
OF BIMAN BANGLADESH AIRLINES OCCURRED ON 16 MAY 2025 AT VGCB, COX'S BAZAR AIRPORT
BANGLADESH.

PUBLISHED BY
THE OFFICE OF THE AIRCRAFT ACCIDENT INVESTIGATION COMMITTEE OF BANGLADESH

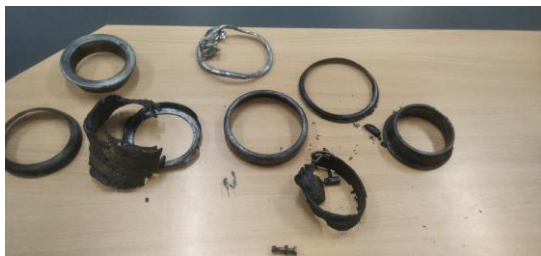
3.1.3.1 Destroyed	No																														
3.1.3.2 Substantially damaged	Brief description of the Damage:																														
	(a) Damage Parts:																														
	<table><tr><th>SL No.</th><th>Part Name</th><th>Part No</th></tr><tr><td>1.</td><td>Outer Bearing Grease Seal metal Part</td><td>39-189</td></tr><tr><td>2.</td><td>Inner Bearing Grease Seal metal Part</td><td>39-188</td></tr><tr><td>3.</td><td>Cone Bearing (Inner)</td><td>28685-20629</td></tr><tr><td>4.</td><td>Cone Bearing (Outer)</td><td>29675-20629</td></tr><tr><td>5.</td><td>Bearing Cup (Inner & Outer)</td><td>29620-20629</td></tr><tr><td>6.</td><td>Bearing Roller (Qty-02)(Inner & Outer Bearing)</td><td>29685-20629 & 29675-20629</td></tr><tr><td>7.</td><td>Metal Chips</td><td></td></tr><tr><td>8.</td><td>Axle Nut</td><td>46127-3</td></tr><tr><td>9.</td><td>Saddle</td><td>46135-1</td></tr></table>	SL No.	Part Name	Part No	1.	Outer Bearing Grease Seal metal Part	39-189	2.	Inner Bearing Grease Seal metal Part	39-188	3.	Cone Bearing (Inner)	28685-20629	4.	Cone Bearing (Outer)	29675-20629	5.	Bearing Cup (Inner & Outer)	29620-20629	6.	Bearing Roller (Qty-02)(Inner & Outer Bearing)	29685-20629 & 29675-20629	7.	Metal Chips		8.	Axle Nut	46127-3	9.	Saddle	46135-1

<p>Figure 4: Damaged parts of the detached wheel.</p> </div> </div>
