**PRELIMINARY REPORT OF INVESTIGATION OF RUNWAY EXCURSION OF SAUDIA FLIGHT SV-806, AIRCRAFT B-777,
REG HZ-AK28, OCCURRED AT VGHS AIRPORT ON 28 JUNE 2023**

This Serious Incident investigation of 'Runway Excursion' involving Saudia Flight SV-806, aircraft type B-777-300, Registration number HZ-AK28, occurred at VGHS airport on 28 June 2023, is being conducted by the Aircraft Accident Investigation Committee of Bangladesh (AAIC-BD), in accordance with Civil Aviation Act 2017 and in conformity with Annex 13 to the Chicago Convention on International Civil Aviation.

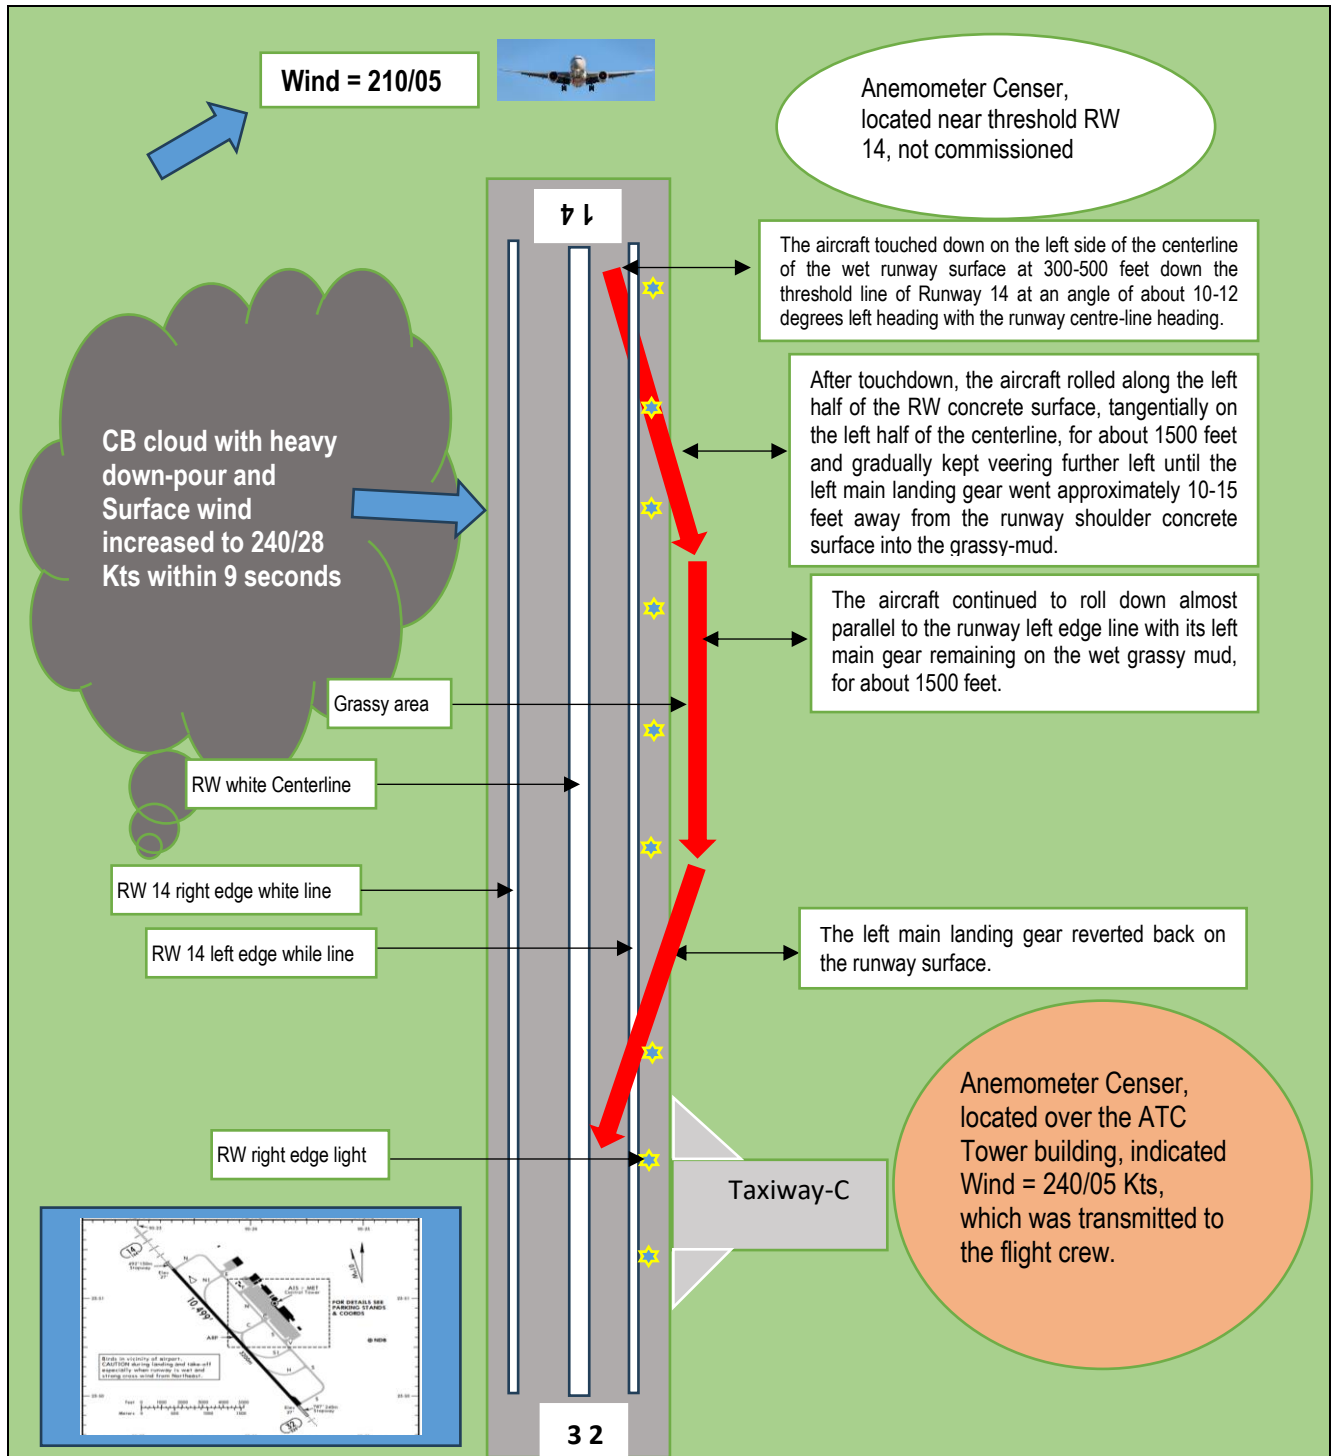
Figure-1 (Diagram is not to scale)

2.1.6 Date of publication or dispatch of report?	26 July 2023
2.1.7 Brief resume of the circumstances leading to the accident/ serious incident/ investigable incident?	<ol style="list-style-type: none"> (a) The Saudia Airlines Flight SV-806, originated from Riyadh (OERK), Kingdom of Saudi Arabia to land at Dhaka (VGHS), Bangladesh on 28 June 2023. (b) To land at VGHS, the aircraft made an ILS approach at Runway 14 in moderate rain with visibility of 1500 Meters and cross wind of 05 Knots from starboard. (c) According to the statement of the flight crew, the aircraft was stabilized on ILS approach for Runway 14 at 1000 feet with autopilot flying. During the final approach, visual contact with the Runway approach lights were sighted by the flight crew while approaching the 'Minima' (261 Feet AGL). At this time the flight crew switched off the autopilot to hand-fly the aircraft for approach and landing. (d) Again, according to the flight crew, the 'Localizer' of the VGHS ILS RW 14 was fluctuating during the ILS approach. when the first visual contact with the approach lights was made by the flight crew, the position of the aircraft was slightly left of the runway approach-line of RW 14. (e) The flight crew, during hand-flying made the necessary correction to align the aircraft with the runway and to continue with the approach to land on runway 14. (f) The aircraft touched down on the left side of the centerline of the wet runway surface at 300-500 feet down the threshold line of Runway 14 at an angle of

<p>about 10-12 degrees left heading with the runway centre-line heading.</p> <p>(g) After touchdown, the aircraft rolled along the left half of the RW concrete surface, tangentially on the left half of the centerline, for about 1500 feet and gradually kept veering further left until the left main landing gear went approximately 10-15 feet away from the runway shoulder concrete surface into the grassy-mud.</p> <p>(h) The aircraft then continued to roll down almost parallel to the runway left edge line with its left main gear remaining on the wet grassy mud, for about 1500 feet. During this time, the left main gear wheels overran over five (5) concrete cable laying iron made pit-covers, of each having dimension of about 6 feet x 6 feet and crashing about three (3) pit-covers and associated structures. Thereafter, the left main landing gear reverted back on the runway surface.</p> <p>(i) The aircraft then rolled down the runway end, back-tracked and was taxied to Parking Bay # 5 via the centre taxi track.</p>
