**PRELIMINARY REPORT**

**INVESTIGATION INTO INCIDENT OF BOEING 737-800 AIRCRAFT REG NO S2-AJA  
 OF US BANGLA AIRLINES LTD OCCURRED ON 02 JANUARY 2024  
 AT VGSY AIRPORT, SYLHET, BANGLADESH.**

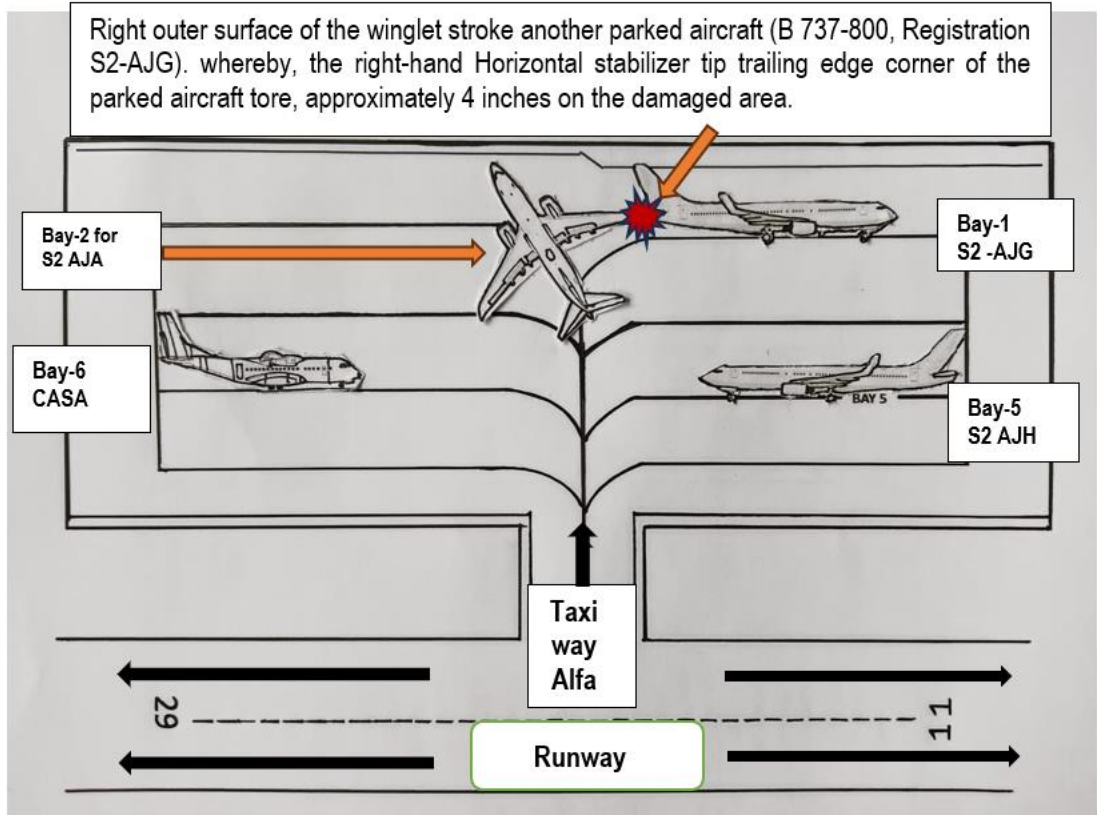
On 01 January 2024, the aircraft took off from Guangzhou Baiyun International Airport for VGHS. Due to poor visibility at VGHS, Dhaka, the aircraft diverted to Osmani International Airport, Sylhet and landed safely at 0207 hrs UTC. After landing, as per the instruction of the Air traffic controller, the pilot followed the Taxiway-A to Bay-2 parking area. In Bay-1 (West of Bay-2), another B 737 of US Bangla was parked. During taxiing in, as aircraft turned left for its parking area Bay-2, the right winglet hit the right at the edge of horizontal stabilizer of parked B 737 aircraft, Reg No- S2 AJG.

**Ground Incident (Collision) between Boeing 737, S2- AJA and S2- AJG**

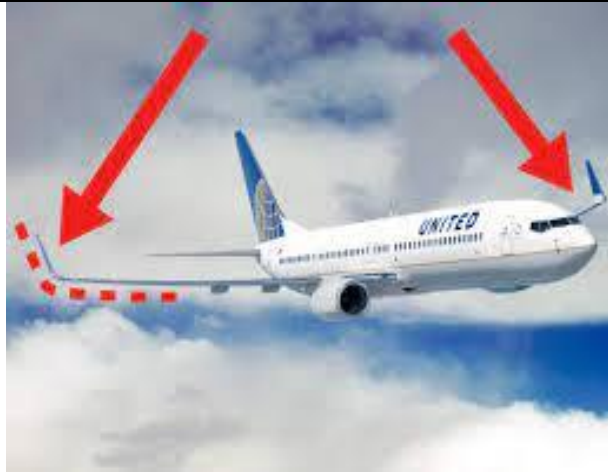
Red arrow mark shows the 'Winglet' of aircraft

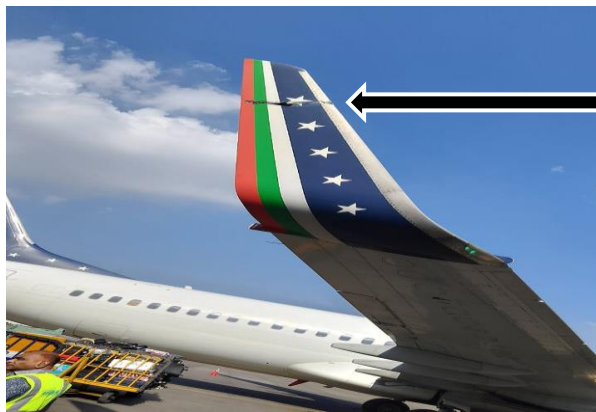
3.1.3.1 Destroyed	No
3.1.3.2 Substantially damaged	(a) With regard to aircraft S2-AJA, the RH winglet outer surface was found torn with approximately 15 inches long split; and. (b) With Regard to S2-AJG, the RH Horizontal stabilizer trailing edge tip was damaged and torn off, approximately 4 inches on the damaged area.
3.1.3.3 Slightly damaged	NIL

Damaged Right winglet of B 737 Reg - S2 AJA

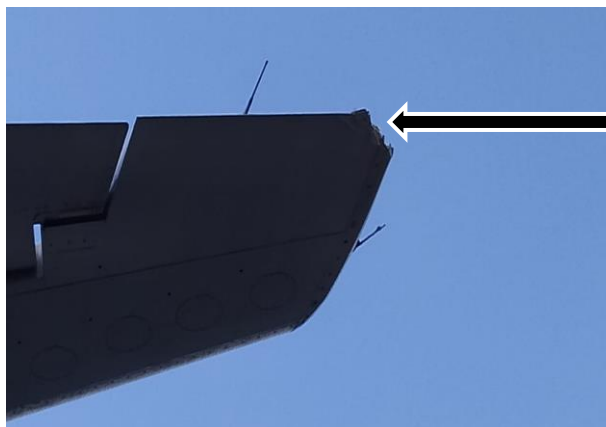
Right aft edge corner of horizontal stabilizer of parked B 737 aircraft, Reg No- S2 AJG.
