FINAL REPORT

Investigation on Serious Incident of HS 748-2A Aircraft Registration S2-AAX on 16 January 2018 of Bismillah Airlines Limited at Jessore Airport of Bangladesh

Investigation on Serious Incident of HS 748-2A Aircraft, Registration S2-AAX on 16-01-2018 of Bismillah Airlines Limited at Jessore Airport of Bangladesh

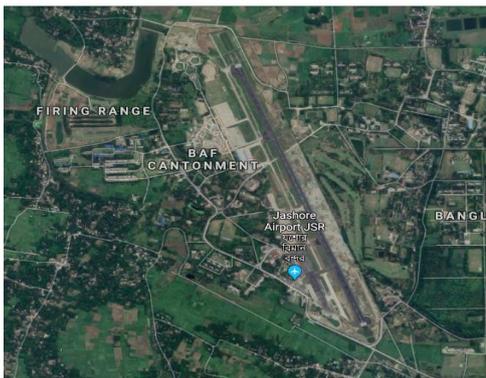
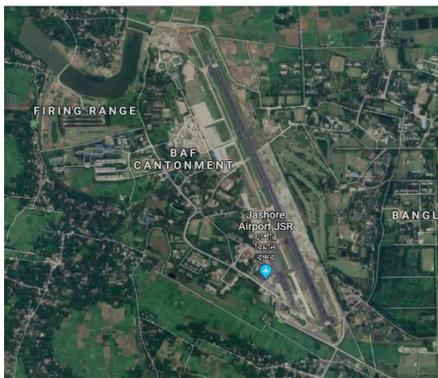
<p align="center">Occurrence site at JSR Airport</p>

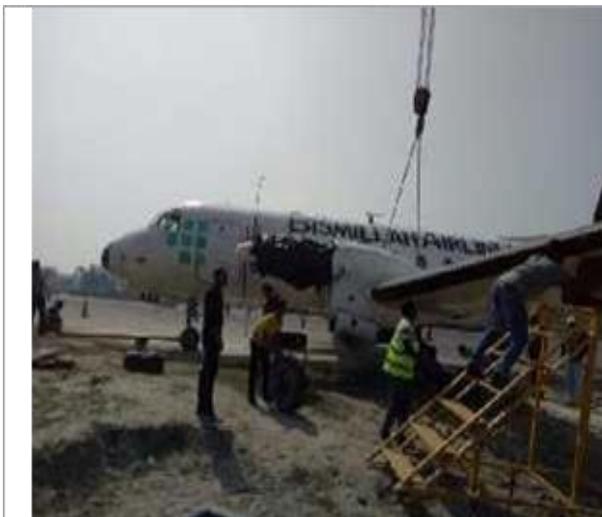
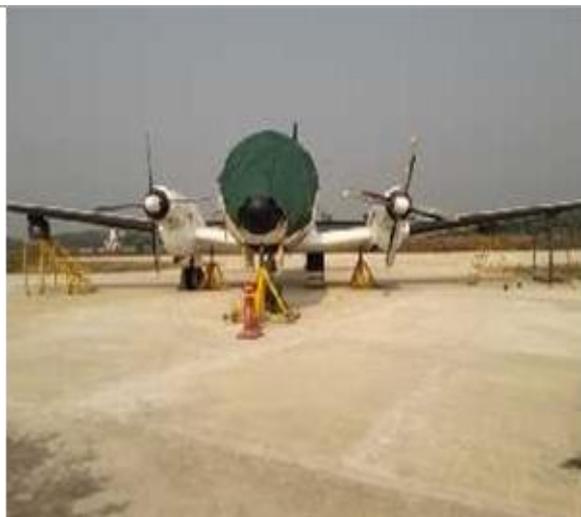
3.3.2	Substantially damaged	<p>a) The aircraft was damaged extensively as follows:</p> <ol style="list-style-type: none"> 1. Port side four (4) blade tips were bent and damaged; 2. Port side Landing gear was broken from attachment; 3. Port side Landing gear door was broken; 4. Port side Landing nacelle was broke and damaged; and, 5. Hydraulic filter inlet connection was found broken.
-------	-----------------------	---

The aircraft was being lifted by crane and was positioned on the airport's parking apron

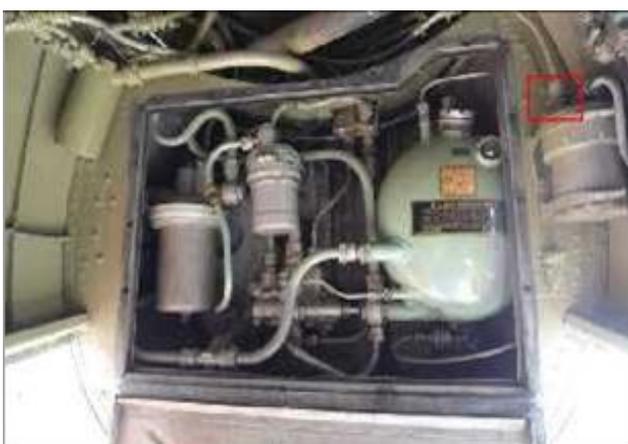
Aircraft's hydraulic system reservoir and filters, the location of the failed hydraulic fitting is marked in the red rectangle

4.2	Machine	a) The hydraulic adapter may have failed at some point after landing. With the left hand hydraulic pump continuing to demand fluid, the fluid pressure may have made a leak in the system that resulted pressure and fluid loss from the main hydraulic system. After loss of the main hydraulic system, the brake accumulators provided pressure for several applications of the brake, which indicates that braking during landing roll and initial taxi was available. Eventually, pressure in the brake accumulators depleted and braking action was lost; b) The illumination of the 4 hydraulic warning lights was obvious regarding the failure of the hydraulic adapter (fitting). As the warning lights are not in the most conspicuous location, it was unlikely that the flight crew could have noticed when they first illuminated, particularly as the last part of the landing roll and the upcoming taxiing of the aircraft by the flight crew required looking out of the wind shield and window; c) The aircraft sustained major damages to the left landing gear and lower wing as well as the left propeller and engine assembly as a result of hitting the ground due to the collapse of the left landing gear; d) It appeared that soon after landing at Jessore airport, the aircraft's hydraulic system failed, resulting in the loss of hydraulic pressure which powers the aircraft's steering and braking. e) It was noted that there were traces of hydraulic fluid leak on the taxiway and not on the runway. Hence it could be presumed that a hydraulic adapter together with the 'hydraulic fitting', located at the hydraulic pressure filter, had cracked and failed during the last part of the landing roll when the aircraft was turned into the taxiway Romeo;

<p>f) Although the reason for the hydraulic fittings is presumed, given the age of the aircraft, and there is likelihood that these fittings may have been installed when the aircraft was initially manufactured in 1979, hence having possibility that material fatigue leading to the damage/crack of the hydraulic fitting may be factor to the loss fluid;</p> <p>g) It may be mentioned here that there is no task card found in the approved Aircraft Maintenance Schedule of this aircraft in connection to the failed hydraulic fitting as this hydraulic fitting has been considered as 'on condition item' and not 'time limited item';</p> <p>h) The investigation team inspected hydraulic fitting of other HS 748 aircraft (Registration Marks: S2-ADW) available in the fleet of Bismillah Airlines Ltd and no crack, bend & damage was noted;</p> <p>i) Following the collapse of the left main landing gear after striking a concrete structure at the side of the taxiway and ditch that was under construction, the left propeller, left engine, left inboard wing and left landing gear structure collided with the concrete surface causing significant structural damage of aircraft.</p>

j) The lower left engine cowling was deformed; k) Hydraulic fittings, located at the hydraulic pressure filter, fractured and failed.
6.2	Flight Crews	The pilots had valid licenses with medical fitness and were rated in type of aircraft.
6.3	Flight Operations	No significant observation.
6.4	ATC	No significant observation
6.5	CVR, FDR and ATC Transcript	CVR and FDR were not decoded; and, No significant observation was found in ATC transcript.

1. Bismillah Airlines Ltd should liaise with the aircraft manufacturer to confirm if the hydraulic fittings on the aged aircraft in their fleet should be replaced as a precautionary measure to avoid recurrence of similar occurrence in future;
2. Quality Management System and Safety Management System should be developed, implemented and maintained adequately by all air operators of Bangladesh, especially all those using aged aircraft.

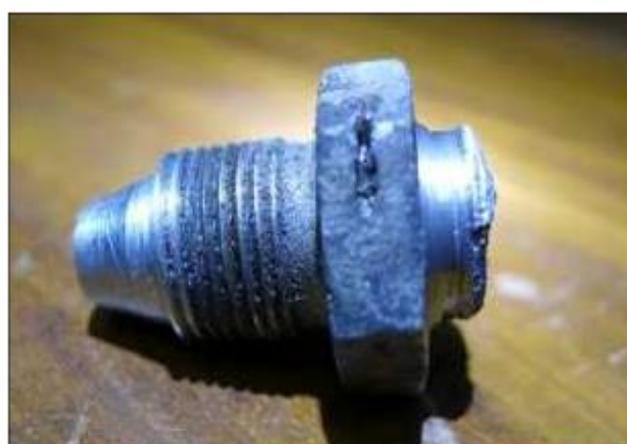
Picture of the failed hydraulic fitting

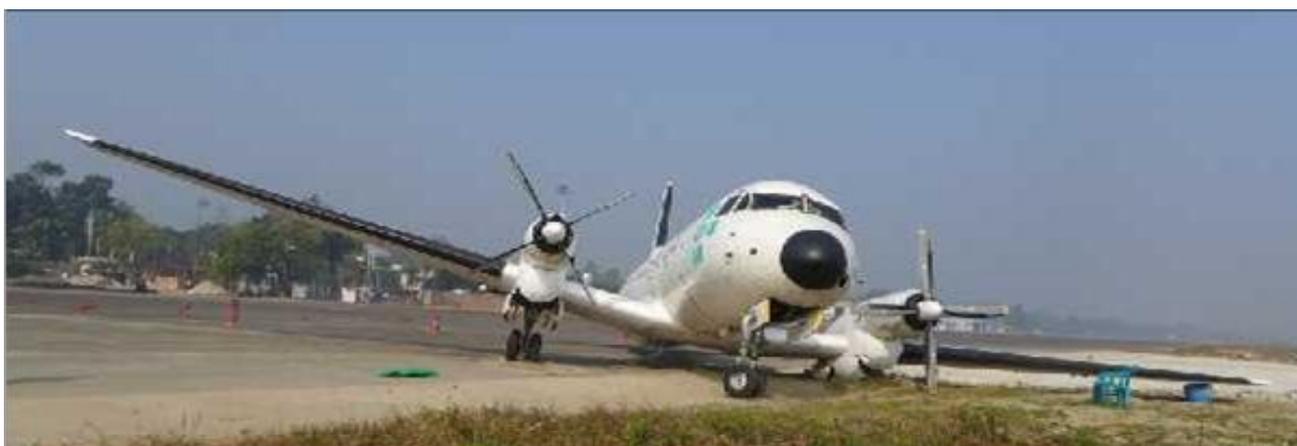
Para	Heading	Description
3.11.1	General information on the site of the accident and the distribution pattern of the wreckage, detected material failures or component malfunctions. Details concerning the location and state of the different pieces of the wreckage are not normally required unless it is necessary to indicate a break-up of the aircraft prior to impact. Diagrams, charts and photographs may be included in this section or attached in the appendices	The aircraft was damaged including its L/H side four (4) propeller blades, landing gear and associated some area.

Aircraft post incident view

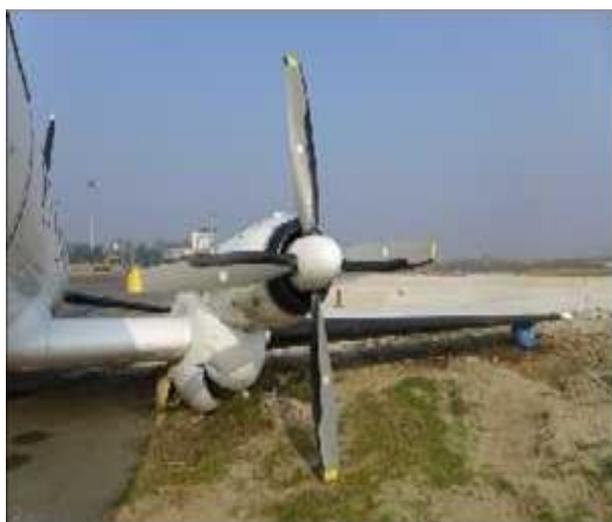
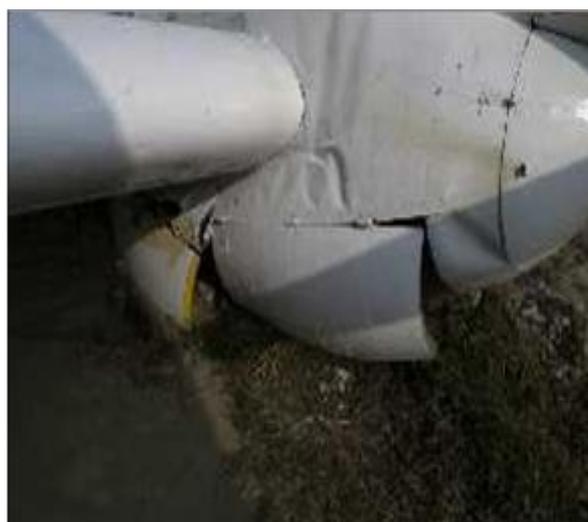
The damaged propeller blades and lower left engine cowling

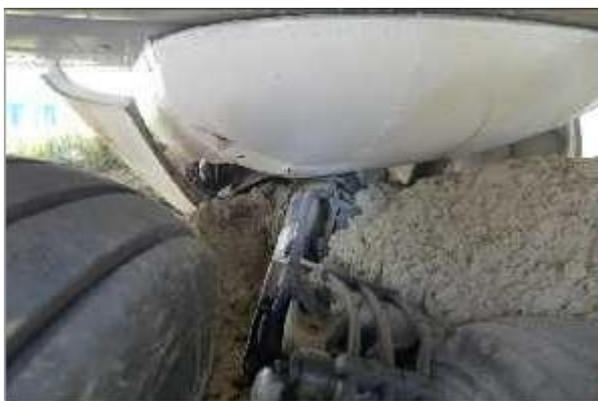
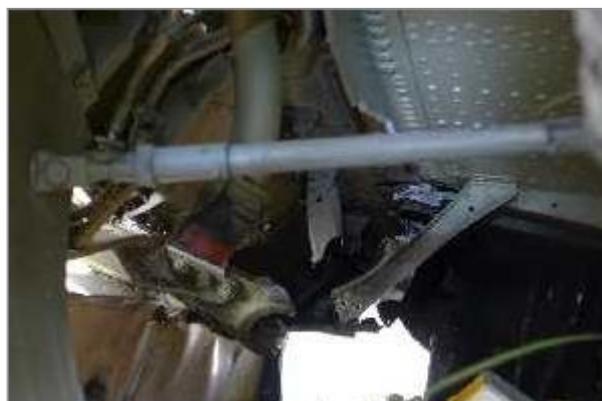
Collapsed & buckled left MLG and Broken / Wrecked MLG under wing frame
