PRELIMINARY REPORT

INVESTIGATION INTO ACCIDENT OF CESSNA-152 AIRCRAFT REG NO S2-AFK
OF GALAXY FLYING ACADEMY LTD OCCURRED ON 09 JANUARY 2021
AT VGRJ AIRPORT, RAJSHAHI, BANGLADESH.

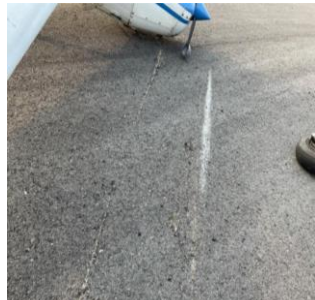
(Figure-1)

3.11.1 General information on the site of the accident and the distribution pattern of the wreckage, detected material failures or component malfunctions. Details concerning the location and state of the different pieces of the wreckage are not normally required unless it is necessary to indicate a break-up of the aircraft prior to impact. Diagrams, charts and photographs	(a) The aircraft made the first contact with the runway at approximately 1500 feet down RWY 35 on to the right half of the centre-line at an angle of about 3-5 degrees with the RWY centre-line track (Figure-1). (b) First Touch-Down Tire Marks indicated a partial dislocation of the right wheel after its heavy touch-down. There was no aircraft part or wreckage found in this area (Figure-1). (c) The second impact of the right wheel, when detached, made prominent cut-marks on the runway bitumen as a result of the broken strut that scratched through the runway bitumen. However, there was no aircraft wreckage found in that area (figure-2). (d) On impact of the nose-wheel, the aircraft engine exhaust pipe-edge cut through the runway bitumen that left prominent scar-mark on the runway surface. The detachment of the nose wheel left a broken clamp-part resting 5-7 feet beside the impact area. The impact of the aircraft propeller also left series of cut marks on the bitumen. However, the propeller tips got bent and left no debris in that area (figure-3).
