REF. NO. 30.00.0000.013.33.005.21 (CESSNA-152/S2-AGG/ 16 MAR 2021)-65

PRELIMINARY REPORT

INVESTIGATION INTO ACCIDENT OF CESSNA-152 AIRCRAFT REG NO S2-AGG
OF BANGLADESH FLYING ACADEMY AND GENERAL AVIATION LTD, OCCURRED ON 16 MARCH 2021
AT LALPUR, R345 DME11 FROM VGRJ AIRPORT, RAJSHAHI, BANGLADESH.

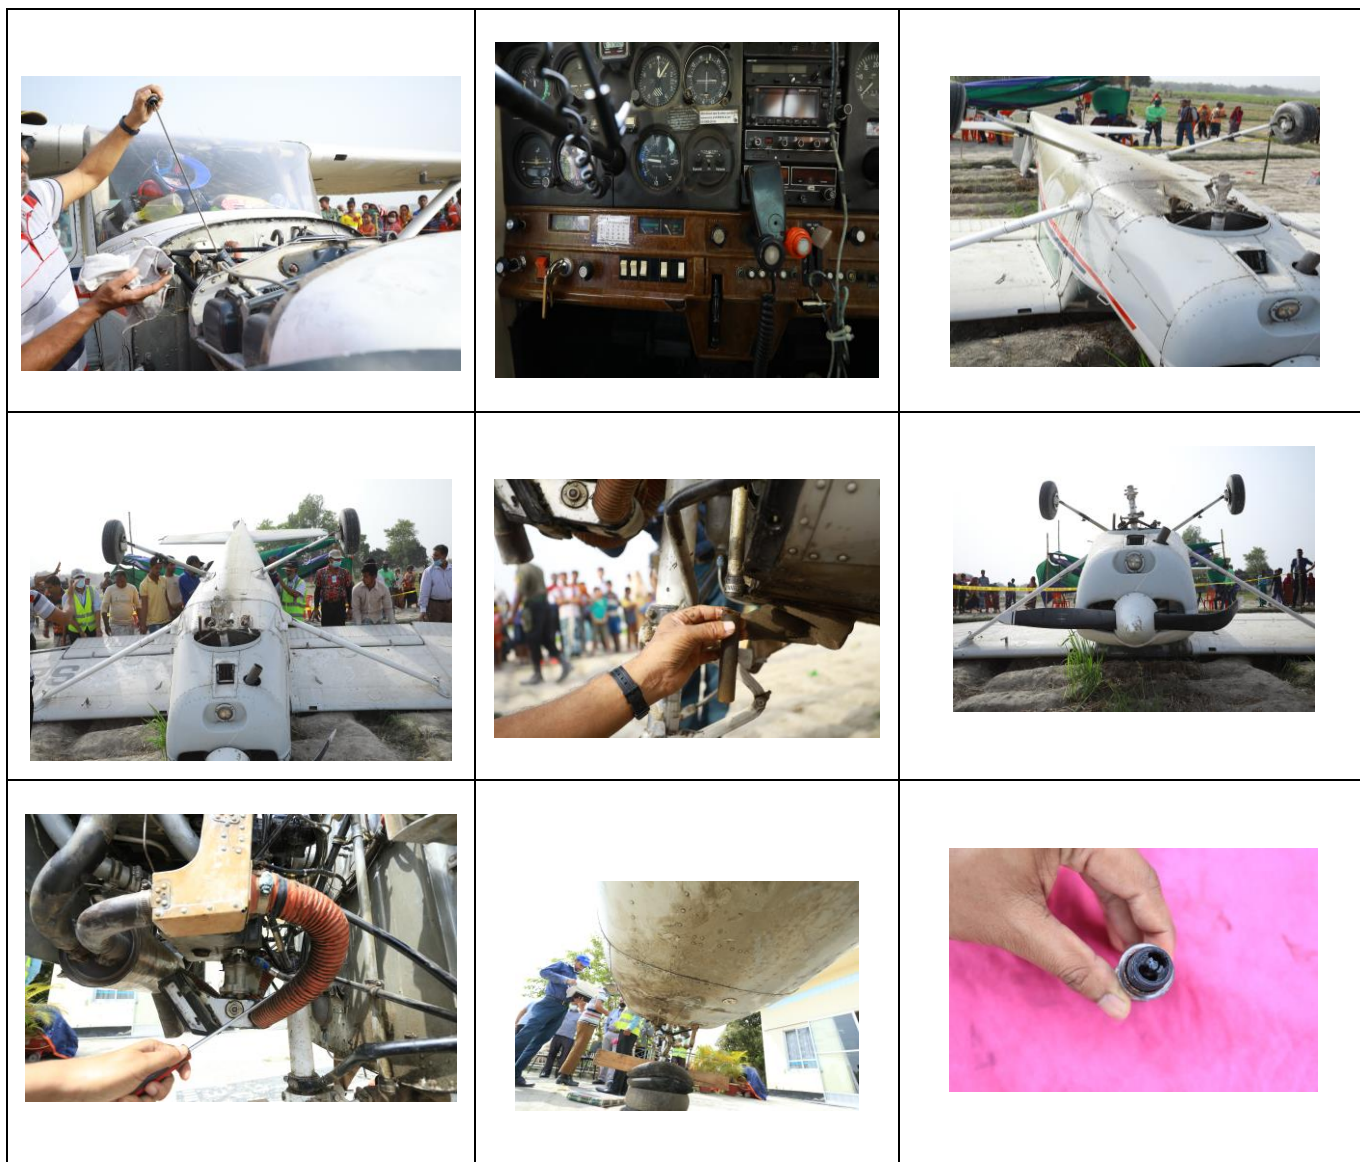
1. Both edges of the propeller bended. (Figure-2)
2. Nose landing gear broke and got detached (Figure-3)
3. Cracks and deformation of both wing surface in several place (Figure-4)
4. Lower tube of oil breather line got broken (Figure-4)
5. Top of the vertical stabilizer and rudder assemblies broke (Figure-5)
6. Deformation of surface of horizontal stabilizer (Figure-6)
