PRELIMINARY REPORT

INVESTIGATION INTO ACCIDENT OF CESSNA-152 AIRCRAFT REG NO S2-AGG
OF BANGLADESH FLYING ACADEMY AND GENERAL AVIATION LTD, OCCURRED ON 16 MARCH 2021
AT LALPUR, R345 DME11 FROM VGRJ AIRPORT, RAJSHAHI, BANGLADESH.

REF. NO. 30.00.0000.013.33.005.21 (CESSNA-152/S2-AGG/ 16 MAR 2021)-65

DATE OF PUBLICATION: 13 APRIL 2021

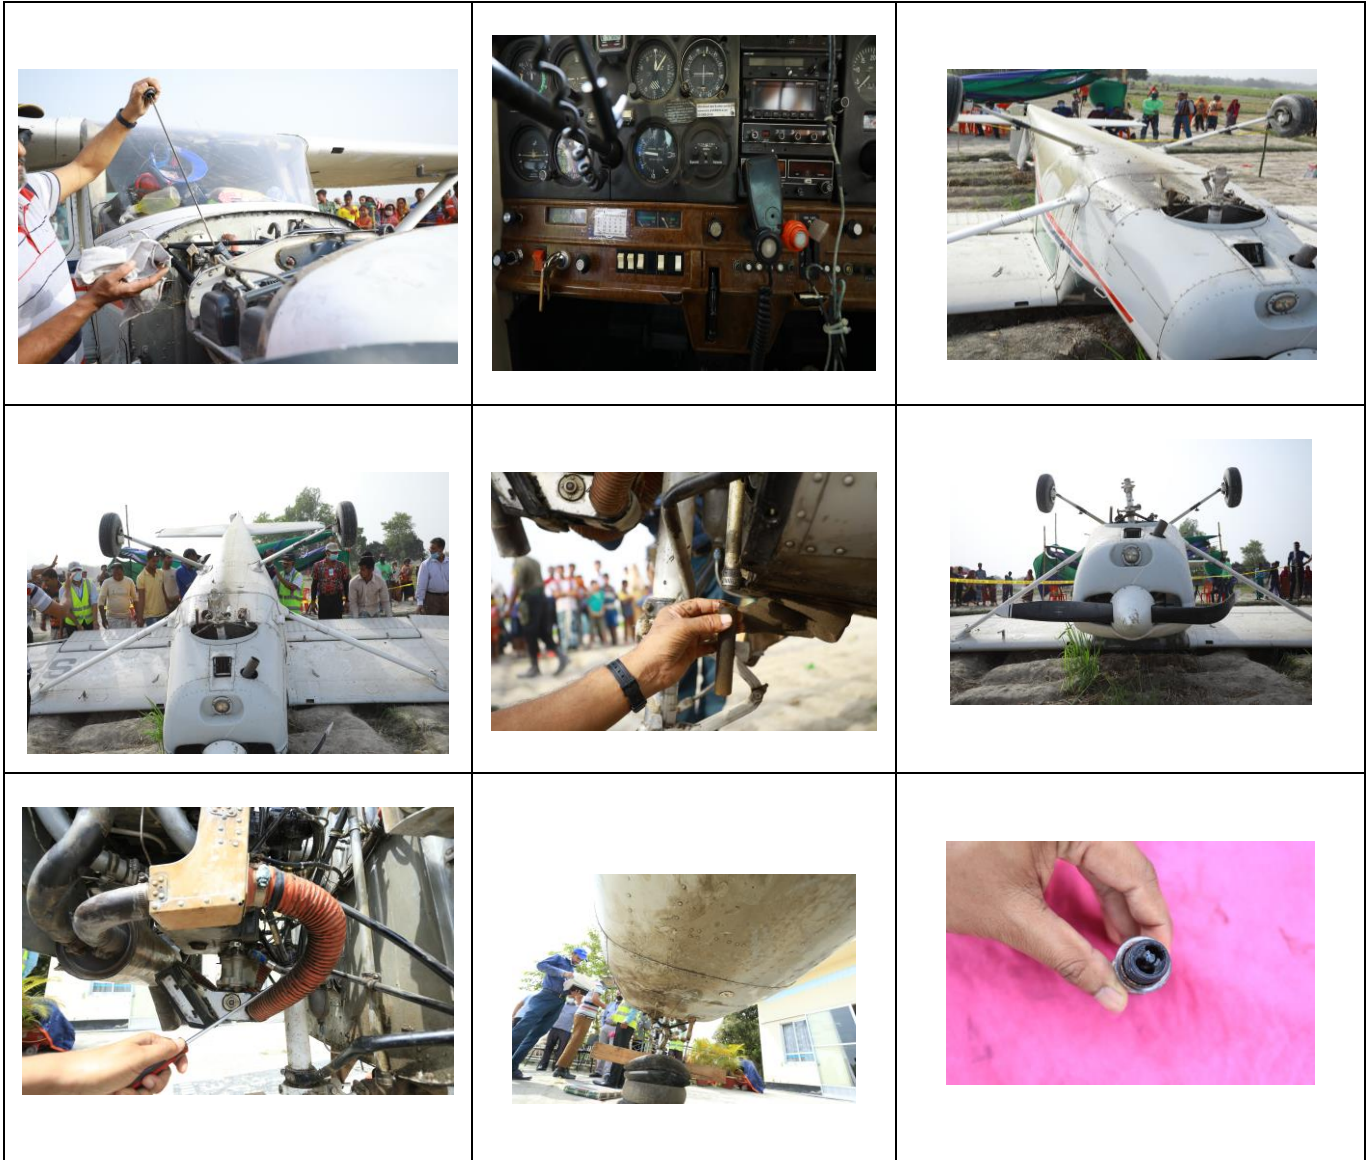
1. Both edges of the propeller bended. (Figure-2)
2. Nose landing gear broke and got detached (Figure-3)
3. Cracks and deformation of both wing surface in several place (Figure-4)
4. Lower tube of oil breather line got broken (Figure-4)
5. Top of the vertical stabilizer and rudder assemblies broke (Figure-5)
6. Deformation of surface of horizontal stabilizer (Figure-6)
