Investigation into the Accident of R-66 Helicopter, Nationality and Registration Mark S2-AGT of Square Air Ltd (SAL) on 01 October 2017 at Chatmohar, Pabna, Bangladesh.

FINAL INVESTIGATION REPORT OF R-66 HELICOPTER ACCIDENT AT PABNA BANGLADESH OCCURRED ON 01-10-2017

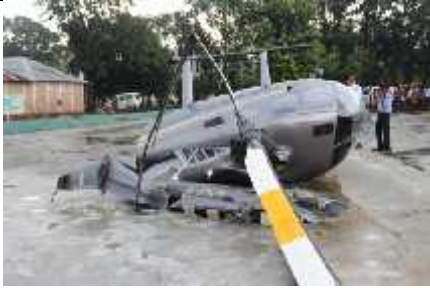
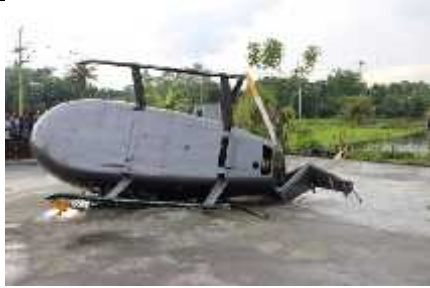
<p>decided to land there. At around 1100 UTC while hurriedly landing and switching off, the helicopter suddenly became uncontrollable and toppled to the right side (pilot side). The pilot, immediately switched off the helicopter and came out through the left door and evacuated all passengers with the help of local people.</p> <p>2.7.3 There were 04 (four) Corporate passengers and 01 (one) pilot onboard at the time of accident. There was no significant injury to the passengers and the pilot.</p> <p>2.7.4 The helicopter was damaged extensively. During initial investigation the following damages were found:</p> <ul style="list-style-type: none"> ❖ Tail boom completely damaged and sheared off from helicopter fuselage. ❖ Tail rotor gearbox broken and sheared off from tail boom. ❖ Both the main rotor blades completely damaged. ❖ Swash plate and link rods badly damaged. ❖ Control tube broken. ❖ Tail rotor guard broken. ❖ Tail rotor transmission broken. ❖ Helicopter fuselage damaged in all areas. ❖ Status of the engine could not be ascertained, but looks damaged. ❖ The helicopter was found to be beyond economic repair. <p>2.7.5 The Pilot and all four (4) passengers were taken to Pabna by Road after the accident. The local doctor checked the pilot and found normal.</p> <p>2.7.6 The AAIT was formed on the same day, 01 October 2017 to investigate the cause of the accident.</p>

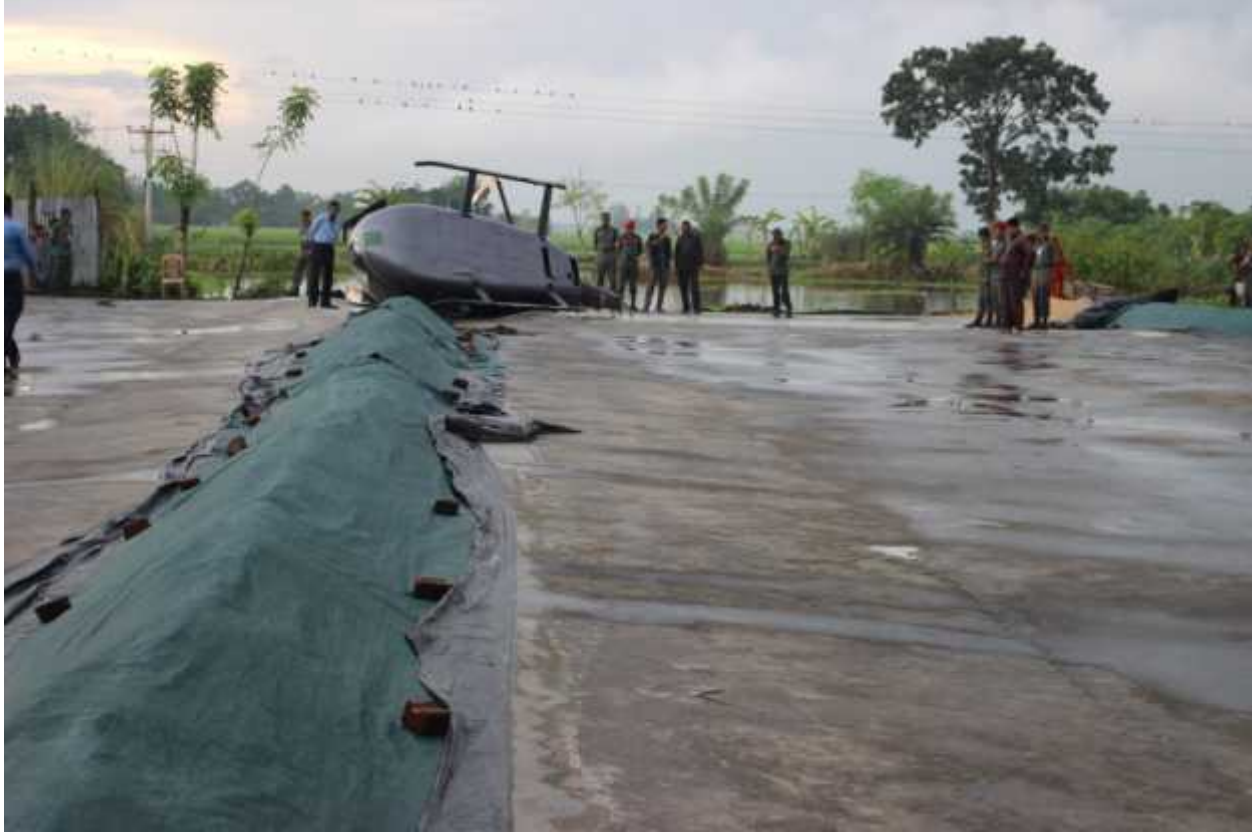
The helicopter was damaged extensively including its engine, rotating blades, structure, landing gear etc. Tail boom completely damaged and sheared off from helicopter fuselage. Tail rotor gearbox broken and sheared off from tail boom. Both the main rotor blades completely damaged. Swashplate and link rods badly damaged. Control tube broken. Tail rotor guard broken. Tail rotor transmission broken. Helicopter fuselage damaged in all areas. The engine driveshaft broke due to heavy stress. The helicopter was found to be beyond economic repair as the total structure was damaged, broken and deformed due to high stress and different type of tensile, compressive and twisting force. The damaged helicopter photographs are shown in the Appendix B.
