## FINAL REPORT

### INVESTIGATION INTO SERIOUS INCIDENT OF ATR 42-300 AIRCRAFT, REG NO. S2-AHI OF NXT AIR LTD, OCCURRED ON 05 JUNE 2022 AT VEGE AIRPORT, CHATTOGRAM, BANGLADESH

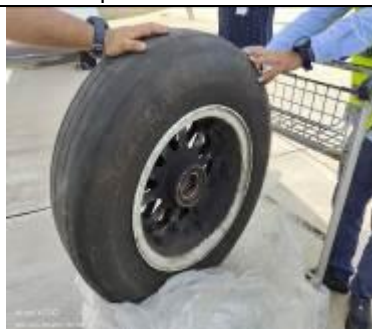
Figure-3: Inner side of the damaged wheel assembly.

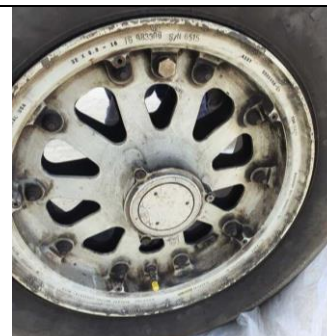
Figure-4: Outer side of the damaged wheel assembly.

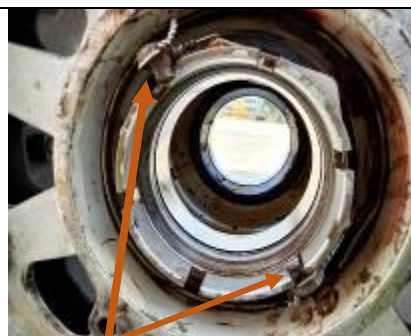
- (1) Locking bolt PT No. AN3H5A (Quantity 2) got broken/sheared off into two pieces. The upper part of both the locking bolts were attached with locking wire with the axle nut of the wheel assembly.

Figure-5: Upper part of the locking bolt attached with the locking wire of the wheel assembly

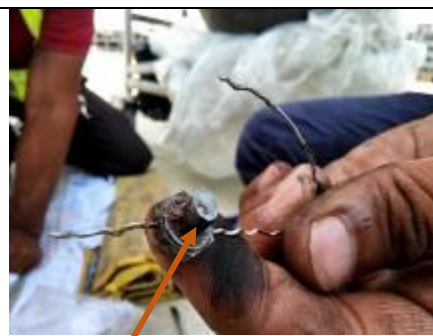
Figure-6: Upper part of the locking bolt with locking wire after removal from the wheel assembly.

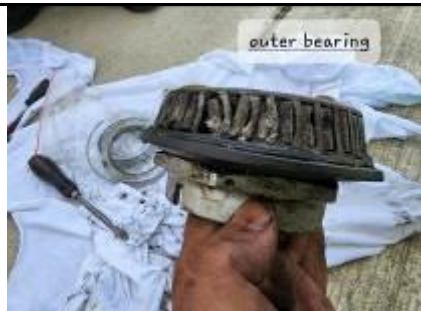
(d) The outer bearing cone assembly PN. L610549 was found damaged, the outer race of the bearing got broken and 8 rollers came out from inside. Found traces of corrosion in rollers and housing of the bearing.

Figure-7: Damaged outer bearing.

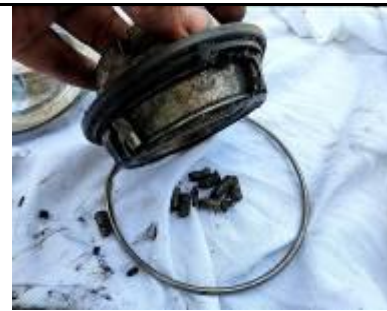
Figure-8: Damaged Roller.

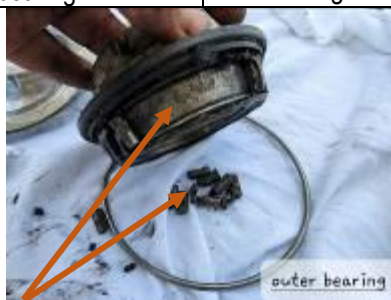
Figure-9: Traces of corrosion of roller and bearing.

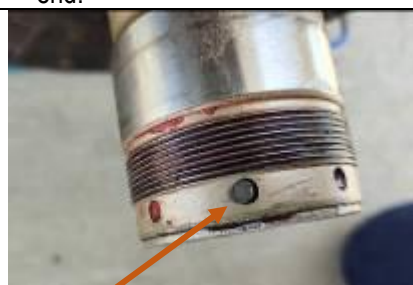
- (e) The team inspected the No.1 left wheel axle PT. No. D57259-2; found lower part of sheared off locking bolts were attached with the axle till the tip of the thread to the other end.

Figure-10: Lower part of the shearing locking bolt attached to wheel axle (Upper View)

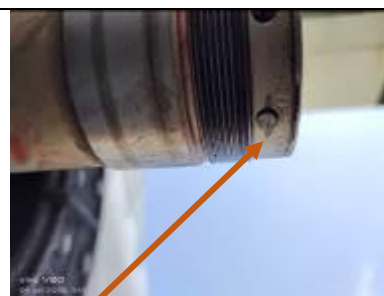
Figure-11: Lower part of the shearing locking bolt attached to wheel axle (Lower View)

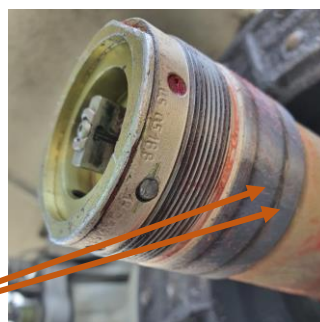
- (f) Scratch marks were found on the shinning portion of the axle which was observed throughout the shinning part circumferentially.

Figure-12: Scratch marks on the shinning portion of the axle throughout the shinning part circumferentially

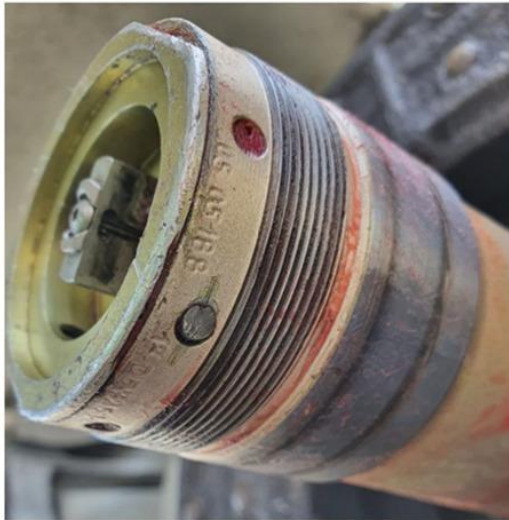
<p>Parker Meggitt comments: General location and orientation of bearing contact marks on axle bearing land area indicate bearing was likely located properly on axle. The sheared locking bolt shaft is visible in the wheel axle bolt hole.</p>

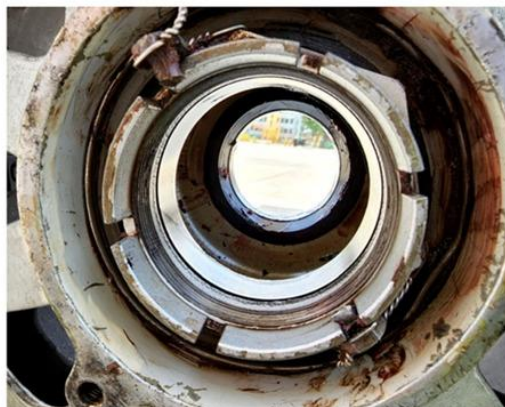
Parker Meggitt comments: The sheared locking bolt heads are still lock wired to the axle nut. The lock wire at the "5 o'clock" bolt head position might be in the improper direction. The axle nut is still attached to the wheel, after the wheel exited the axle. The retaining ring is still in place, keeping the outboard bearing in the wheel.

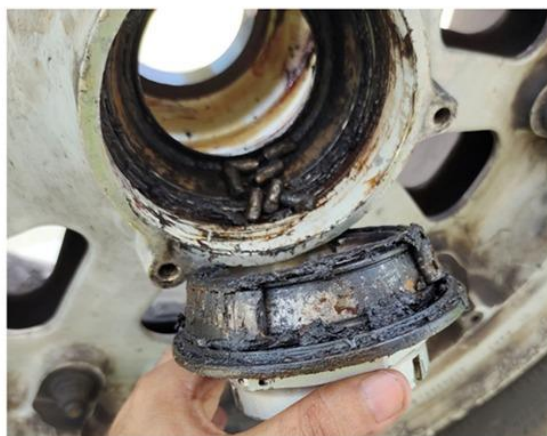
Parker Meggitt comments: Loose and visibly damaged bearing rollers; damaged and missing portions of cage indicate severe bearing damage.

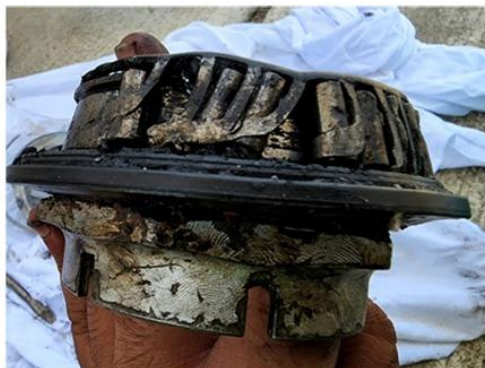
Parker Meggitt comments: The damaged cage and skewed orientation of bearing rollers indicate severe bearing damage.

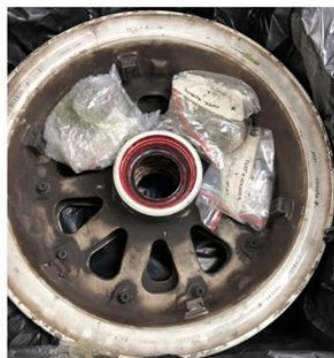
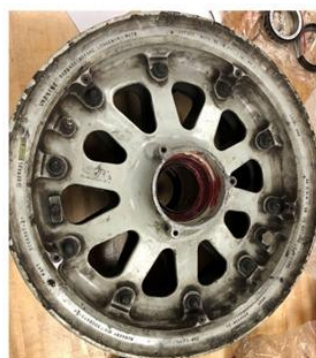
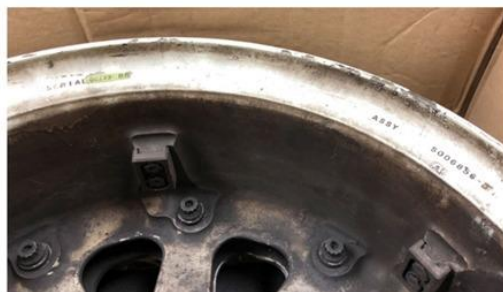
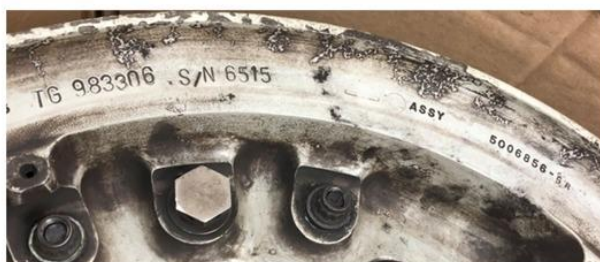
The wheel and bearing parts were adequately packaged to prevent further damage during shipping. Both bearing cups appeared to have fresh grease applied to preserve the bearing race surfaces. The overall condition of the wheel surfaces (dirt/missing paint/corrosion) indicate the wheel was not recently overhauled.

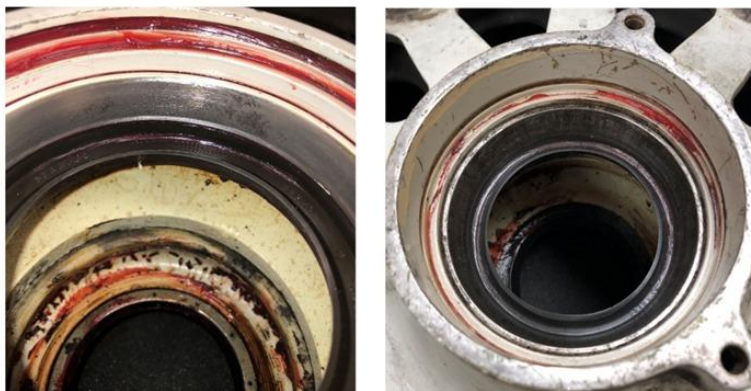
The elastomer grease retaining rings (back side of bearing cups) on both the inboard and outboard side look normal (no signs of distortion or damage). Visual examination indicates no looseness or cup movement (rotational or lateral) within wheel hubs. The bearing cups have corrosion on the roller contact races. The outboard bearing cup corrosion is more severe and over a larger surface area (see Timken report for additional information).

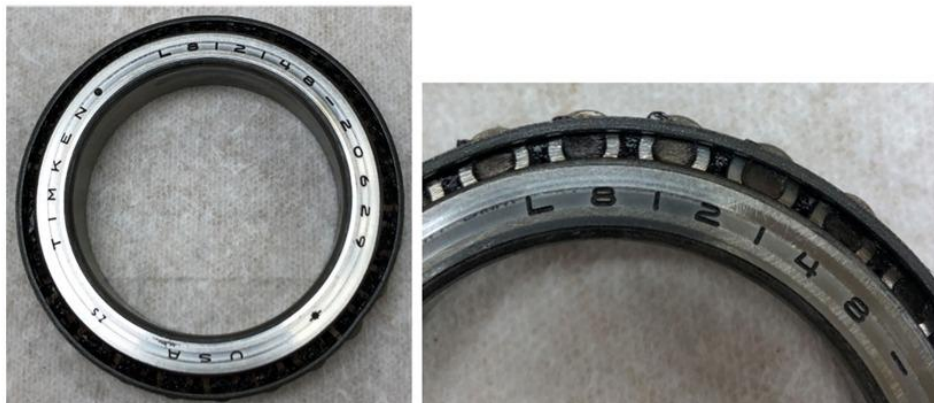
The inboard bearing cone has the correct part number and appears to be in good condition except for light corrosion on the cage (see Timken report for more information).

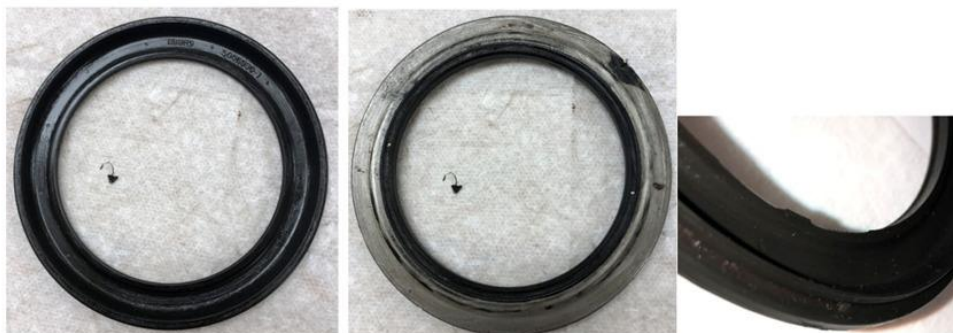
The inboard bearing seal has the correct part number but has a localized cut area. A measurement from the metal face to the seal lip indicates the seal does not meet the reference CMM dimensional requirement for return to service.

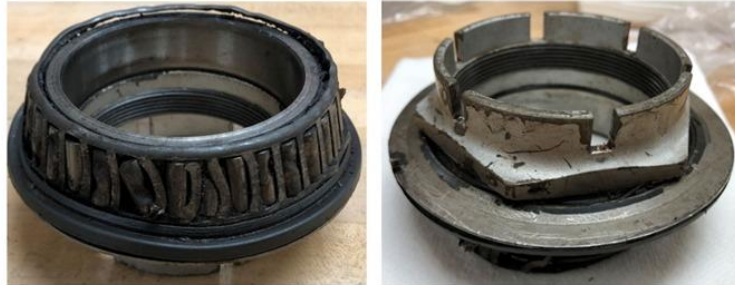
The outboard bearing cone could not be separated from the axle nut without concern of damaging the axle nut. The bearing cone and bearing seal part numbers could not be confirmed; however, a dimensional check of the seal outside diameter and review of visible features matches the drawing.

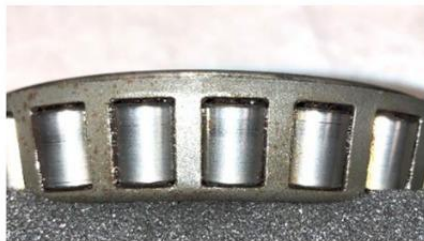
Very light frosting on roller bodies. Light corrosion on cage.

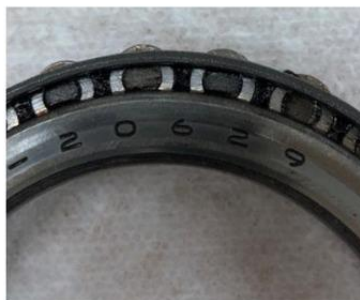
Roller ends in good condition  
Figure 2

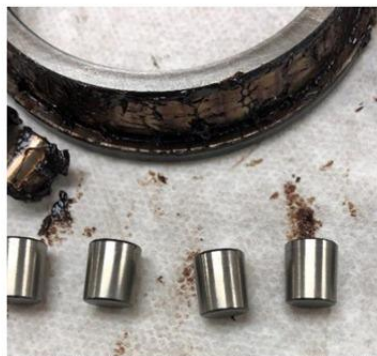
Grease is discolored, but appears to be in good condition  
Figure 1

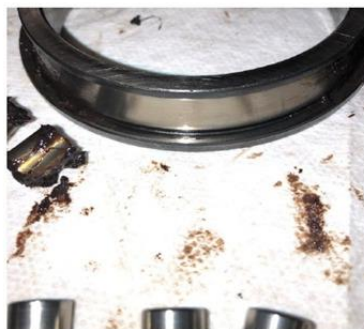
Cone raceway in good condition  
Figure 2

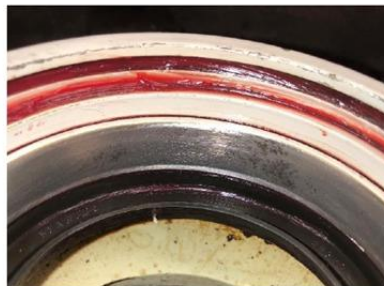
Light corrosion on cup raceway  
Figure 3

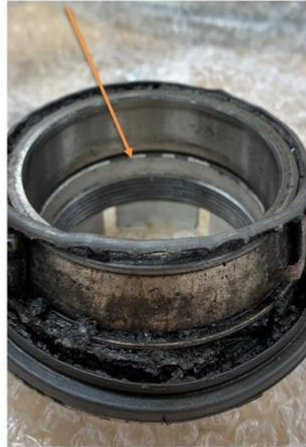
Cone and locknut welded together. Signs of corrosion and flaking paint near interface  
 Figure 4

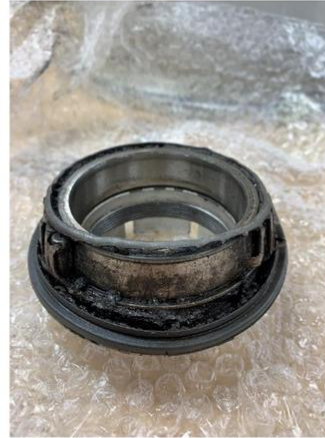
Cage bridges non-existent on half of cone  
 Figure 5

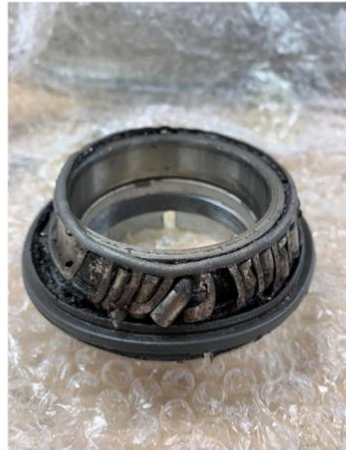
Cage and rollers skewed on half of cone. Fractured roller bodies  
 Figure 6

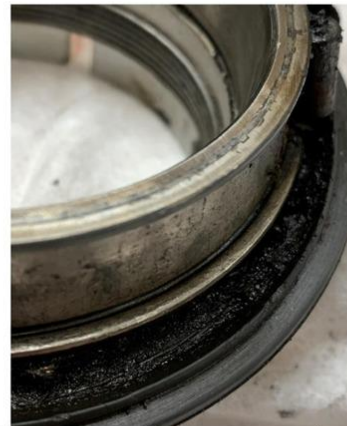
Corrosion on cone front face. Heavy scoring on roller ends  
 Figure 7

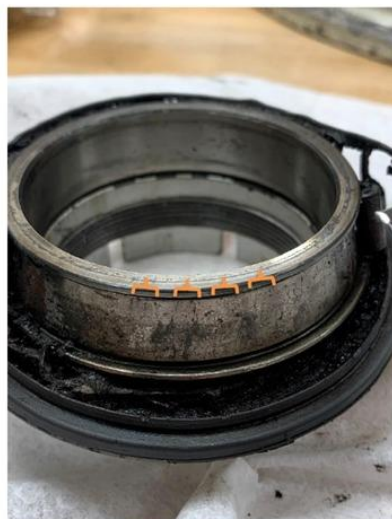
Roller spaced etching on cone raceway  
 Figure 1

The outboard bearing had evidence of extreme corrosion etching on all rollers and raceways. This is typically a result of water or condensation collecting in the bearing. The most advanced etching appeared to be roller spaced on the cone raceway and along the roller body which indicates the damage occurred when the bearing was stationary. It is important to regularly inspect for damaged, worn, or inadequate seals. It is also important to note that bearings should be properly washed and dried during the inspection process. After cleaning and drying thoroughly, the bearings should be coated with a rust preservative and wrapped in protective paper. Once protected, always store bearings in a dry area until installation to reduce the risk of static corrosion.

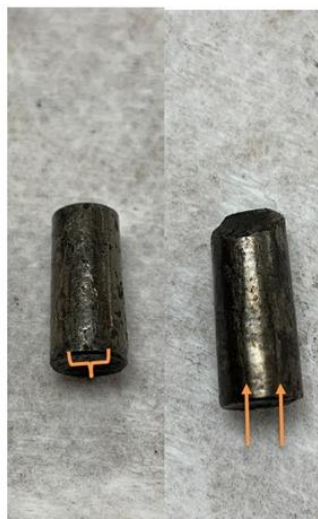
Etching along roller bodies  
 Figure 2

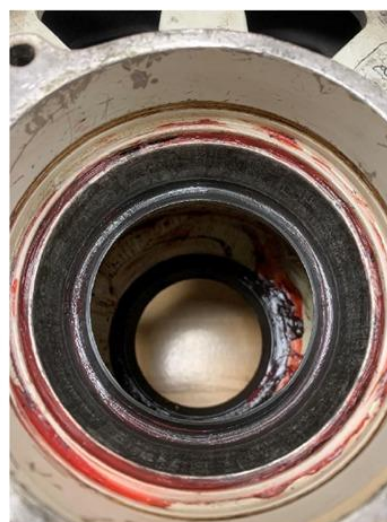
Etching and smearing around entire cup raceway  
 Figure 4

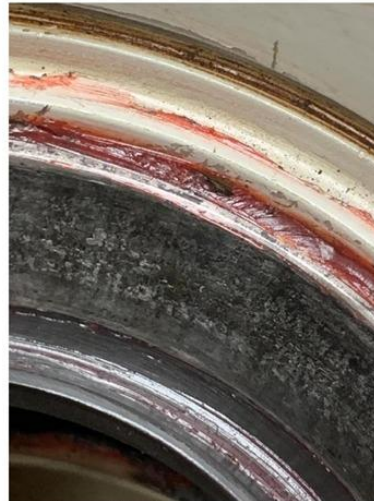
Heavy etching beneath smearing damage  
 Figure 5

Excessive etching on a bearing can dramatically affect the fatigue life of the bearing. The voids created from corrosion etching can progress into spalling and eventually roller fracturing. It is likely that once the rollers began to spall and fracture from the etching damage, they were no longer rolling and began to slide along the raceways. The sliding of the rollers created an excessive amount of heat in the bearing and destruction to the cage. At this point, the bearing had an extreme amount of drag, so it is possible the cone locked to the cup and wheel, where it began to turn on the shaft. Once spinning on the shaft, rotating relative to the locknut, it welded to the locknut and sheared the locking mechanism. The cone and locknut were then free to exit from the wheel.
