FINAL REPORT

**Investigation into the accident of EC-130 B4 Helicopter, Nationality and Registration
 Mark S2-AHW of ATL Aviation Ltd, Occurred on 11 October 2018
 at Godagari, Rajshahi, Bangladesh**

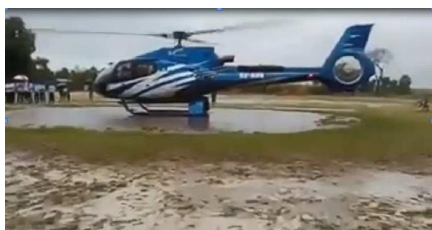
The Helicopter with the rotor turning on ground on the helipad before take-off revealed a lot of puddles of water on ground as the result of a recent rain (monsoon season). The aircraft was parked on the helipad for two hours since the previous flight.

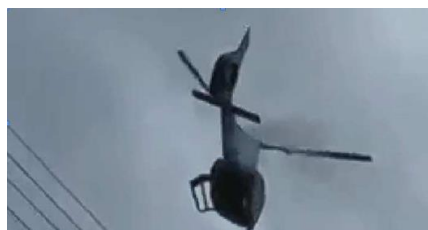
Aircraft just after take-off. Sudden right jerk and bank to the right observed (consistent with sudden loss of power).

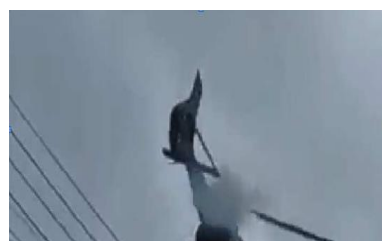
White smoke coming from the exhaust pipe and aircraft losing altitude

Aircraft losing altitude

It is analyzed that the smoke that came out from the engine exhaust pipe is consistent with an engine flame out with fuel

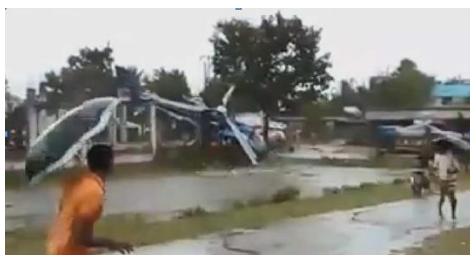
Aircraft impacting the under-construction building area with a lot of Main Rotor Blades conicity (result of low Nr speed and high collective pitch = pilot action to maintain lift). 'During take-off roll at about 60 to 70 ft. altitude, the collective was already in higher position. Once the engine failed at that height, pilot had no other option other than quickly to raise the collective further to cushion the landing. Thereby, high collective pitch input without engine power led to low Nr.'

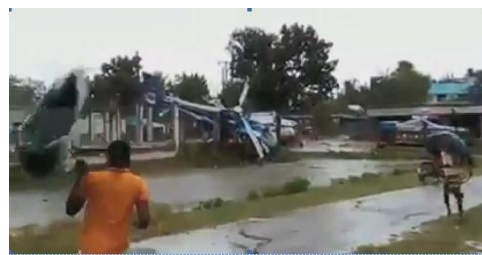
Few seconds after the crash a strong gust of wind is observed (umbrella roll over = result of rotor blast or weather conditions?).

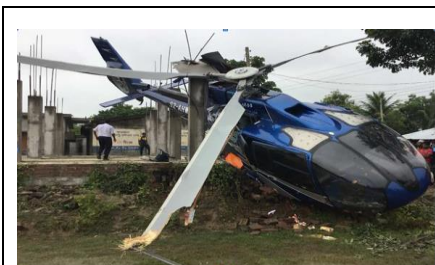
View from the front R/H side

- (a) The helicopter was lying on its belly in contact with the edge/angle of an under-construction building. The right side of the landing gear was broken as a result of the impact with the edge/angle and a concrete pillar of the under-construction building.

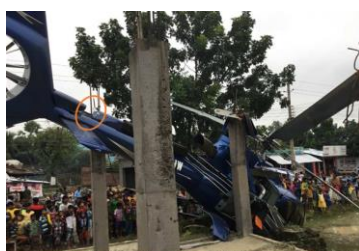
View from the back R/H side with the evidence of tail boom impact with a Main Rotor Blade

- (d) The tail boom evidenced an impact mark with a concrete pillar on its rear L/H side but also with a Main Rotor Blade which has cut the rear transmission cowling and the tail rotor drive shaft just above the horizontal stabilizer.

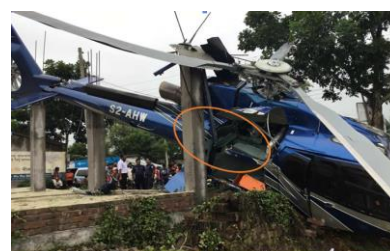
View from the R/H side

- (b) The impact with the concrete pillar has also produced a tear-off of the right side of the MGB deck as shown on the photo, 'view from the R/H side'.

- (c) The helicopter was in pitch down attitude and was inclined to the right in contact in the rear part of the R/H side of the engine (cowling and exhaust pipe) with a concrete pillar which maintained the aircraft in such position.
