PRELIMINARY REPORT

INVESTIGATION INTO INCIDENT OF BOEING 737-800 AIRCRAFT REG NO S2-AJD
OF US-BANGLA AIRLINES OCCURRED ON 21 OCTOBER 2022 AT VGHS, HAZRAT SHAHJALAL INTERNATIONAL
AIRPORT, DHAKA, BANGLADESH.

PUBLISHED BY
THE OFFICE OF THE AIRCRAFT ACCIDENT INVESTIGATION COMMITTEE OF BANGLADESH

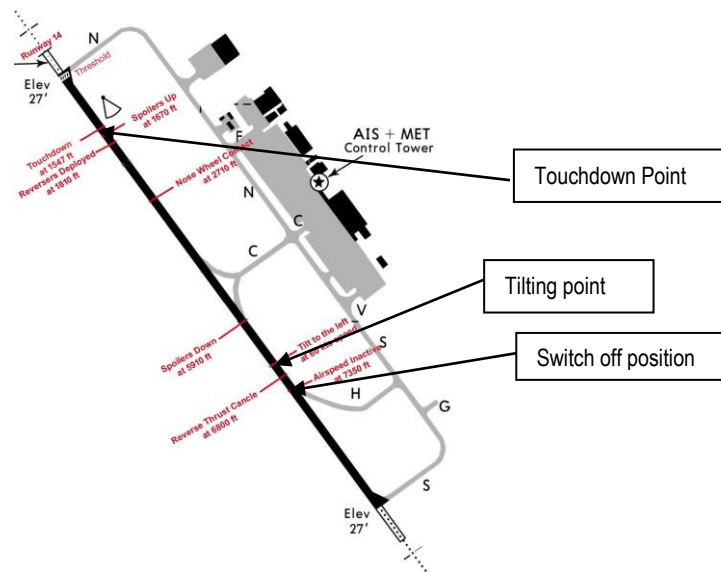
(a) The aircraft touched down at 1547 feet from threshold of runway 14. After touch down, auto brake was disarmed within 85 to 75 knots following which the aircraft vibration started. The vibration increased with further slowing down of the aircraft and the aircraft tilted as it continued to roll down the runway.

(b) The above figure shows the touchdown point, tilting and switch off point of the aircraft near to taxiway 'H'

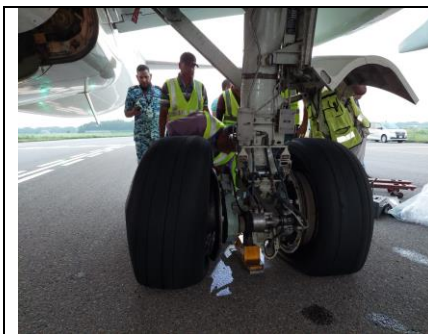
Photograph: (c) 01

3.1.3.1 Brief Description of Damage	The following items/parts of the aircraft got damaged: (a) Tire, Part No: APS06015, Serial No: Y20YC406, manufactured by Bridgestone of no #1 position of left wheel, part no: 2612311-1, Serial No: B7976 got depleted. (b) 7 bolts, Part No: 2613109 of no. #1 position left wheel were sheared off out of 18 bolts. (c) Tire, Part No: 441K82-1, Serial No: 22515039, manufactured by 'Goodyear' of no # 2 position of left wheel got Bruist and depleted.
-------------------------------------	--

(c) Both the tires of left wheel got depleted, shown below:

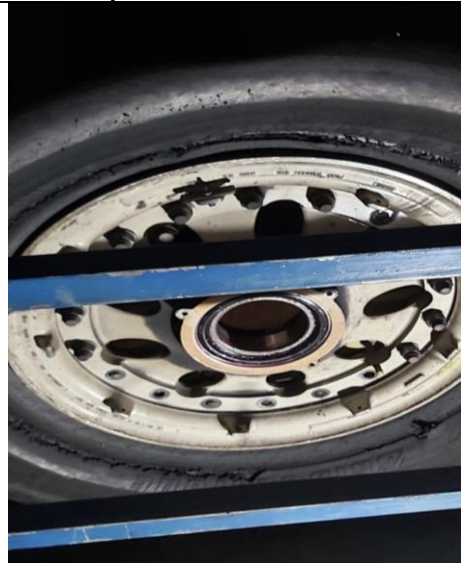
Photograph: (d) 01

(d) The wheels from the switched off area of the aircraft to a safer place in high-speed taxiway 'H' is shown below:

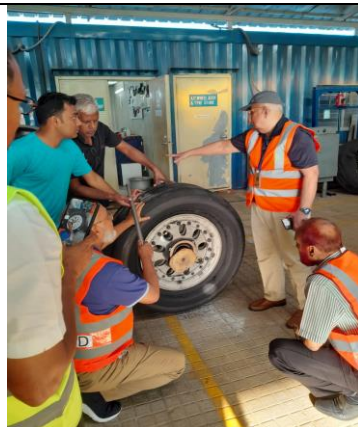
Photograph: (e) 01

(e) Investigation of damaged left wheels by the AAIC-BD members at wheel shop of US-Bangla Airlines. Some of the photographs are shown below:

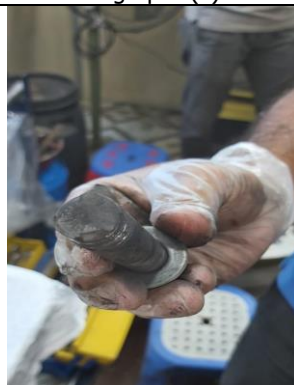
(h) Bolt details:																					
	1. The bolt part no. 2613109 manufactured by Honeywell was installed in no. #1 position of left wheel on 22 November 2020 and completed 865 cycles.

2. The life of the bolts is 5000 cycles. In every tire change, inspection is carried out on physical condition as per CMM. But if, followed the life replacement plan NDT (MPI) is optional.

Photograph: (e) 03
(Shinning portion of broken bolt)

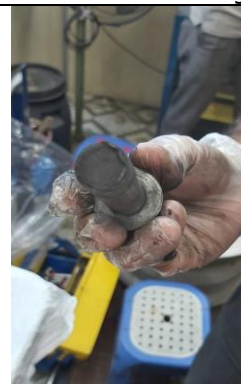
Photograph: (e) 04
(Full dullness of broken bolt)

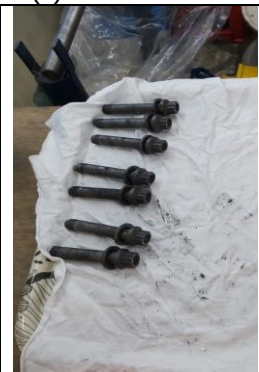
Photograph: (e) 05
(Seven broken bolts)
