**INVESTIGATION INTO ACCIDENT OF CESSNA-152 AIRCRAFT REG NO S2-AFK
OF GALAXY FLYING ACADEMY LTD OCCURRED ON 09 JANUARY 2021
AT VGRJ AIRPORT, RAJSHAHI, BANGLADESH**

**PUBLISHED BY
OFFICE OF THE AIRCRAFT ACCIDENT INVESTIGATION COMMITTEE OF BANGLADESH**

REF. NO. 30.00.0000.013.32.006.21 (CESSNA-152/S2-AFK/09 JAN 2021)-137

DATE: 24 JULY 2022

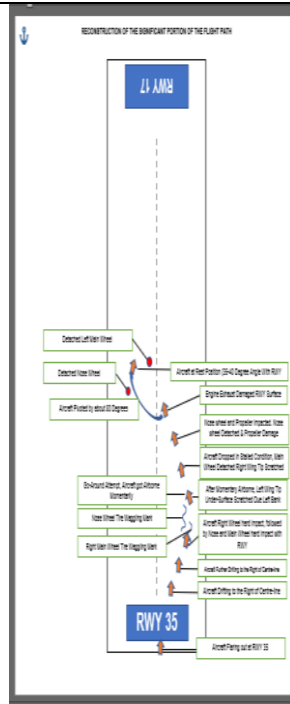
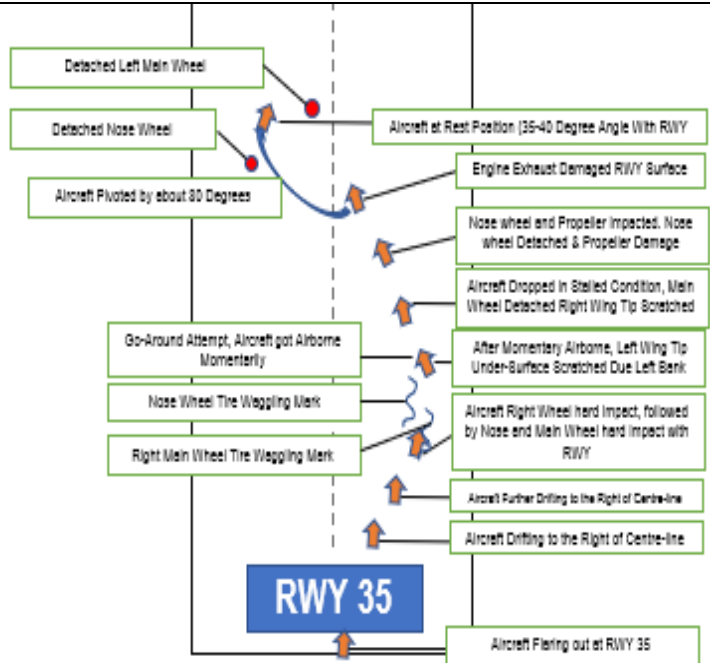
3.1.1.8
 Reconstruction of the significant portion of the flight path?

- (g) The aircraft was started around 0835 UTC and got airborne at 0843, initially for a general flying at 1500 feet AGL that included a few 15–45-degree bank turns, stalls etc. After about 15 minutes of aerial works, the SP was instructed by the IP to join the circuit for a Zero-Flap landing at RW 35 followed by a 'Touch & Go'. The SP followed the instruction and attempted the approach and Touch & Go procedure. According to the IP, the SP's final approach was a bit steeper than normal with about 70-75 knots of IAS. The aircraft crossed the Runway threshold at about 55 feet AGL. At this time, as per the IP, the aircraft started drifting to the right when the IP advised the SP to go left towards the centre line. During this process the right main wheel touched heavily on the right half of the runway centre line.

- (h) At this stage, the instructor pilot took over the aircraft control, added full power in an attempt to go around and applied left bank prematurely to move the aircraft towards centre line of the runway. This resulted the aircraft to lift off by about 2-5 feet height momentarily followed by the left-wing tip of the aircraft striking the runway surface and thereby making dents and marks on its under-surface and tip area. Thereafter, the aircraft stalled and fell on the runway surface causing the accident.

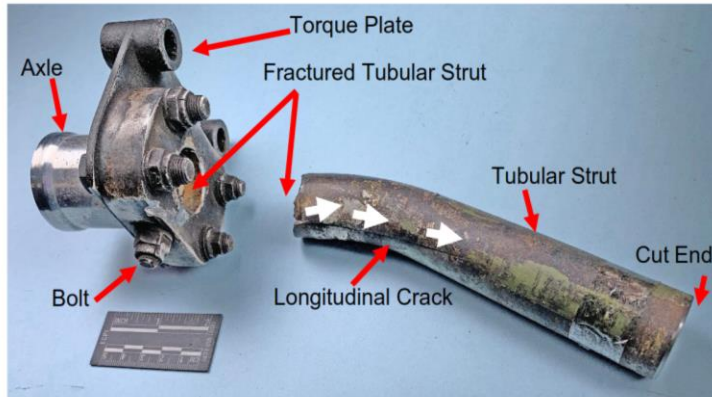
3.1.16.1 Brief statements regarding the results of tests and research?	<p>a) The damaged specimen Spring Assembly-Right Landing Gear Part Number: 0441212-6 was sent to Local NDT (Non-Destructive Test) facility. NDT experts opined that no positive result could be obtained of this damaged specimen as it had already broken in to two pieces.</p> <p>b) On the very first day that is on 10th January 2021 the team looked into the broken area of the damaged specimen through magnifying glass and found that in both broken ends were shining and there was no symptom of dullness in those portions thereof. This means that the spring assembly was broken instantaneously during the second touchdown.</p> <p>c) To find out the root cause of the failure, the AAIT sent the damaged Spring Assembly Landing Gear RH, Pt No. 0441212-6 & AXLE- Main landing gear Attaching Parts, Pt No 0441203-1 for 'Material Test' in the laboratory of National Transportation Safety Board (NTSB), 490L 'Enfant Plaza, SW Washington, DC 20594, USA on 23 January 2022.</p> <p>d) The NTSB carried out the 'Material Test' in the laboratory of National Transportation Safety Board (NTSB) and sent the test report on 31 March 2022. The details of the test report are given below:</p> <p>“As received photographs of the lower portion of the right main landing gear (RMLG) are shown in figures 1 and 2. The RMLG fractured at the lower portion of the tubular strut assembly in the general area of the torque plate. The fracture was oriented generally in the transverse direction. The tubular strut also contained 3-inch longitudinal cracks on diametrically opposite sides that extended from the transverse fracture. These pieces were ultrasonic cleaned withalconox, a detergent that removes iron oxide from ferrous metal. Bench binocular microscope examination of the fracture faces revealed coarse texture fracture on slant planes consistent with overstress separation. The fracture faces showed no evidence of fatigue cracking”.</p>

Figure 1. As-received lower portion of the RMLG assembly showing the axle, torque plate for the brake assembly, and mating fractures of the tubular strut (spring assembly). The longitudinal crack propagated in the general direction indicated by white arrows.

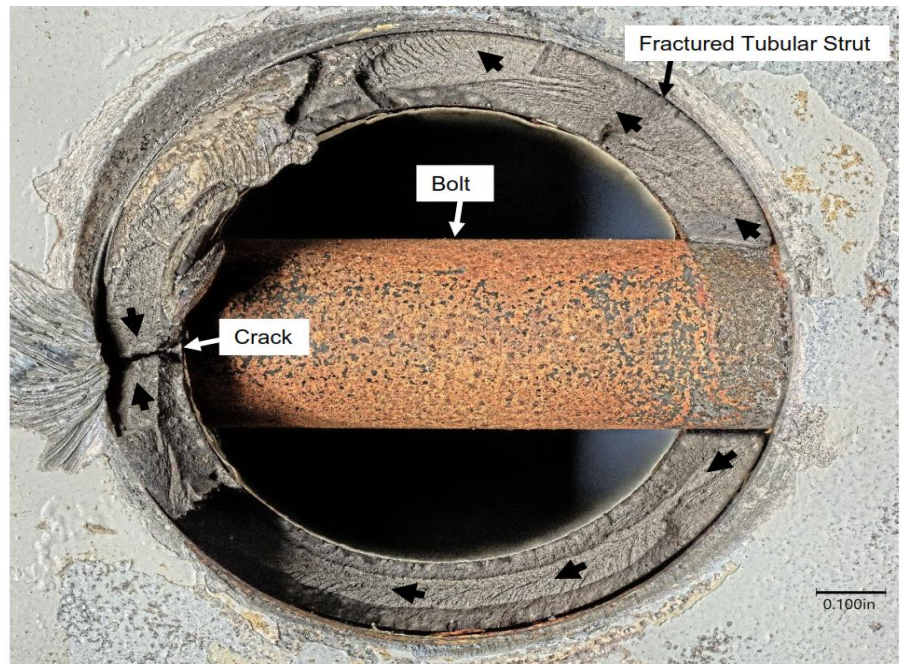
Figure 2. Fracture face of the tubular strut after cleaning with Alconox showing the general direction of fracture propagation (indicated by arrows). This is the fracture face on the side of the axle.
