FINAL REPORT

INVESTIGATION INTO ACCIDENT OF CESSNA-152 AIRCRAFT REG NO S2-AFK
OF GALAXY FLYING ACADEMY LTD OCCURRED ON 09 JANUARY 2021
AT VGRJ AIRPORT, RAJSHAHI, BANGLADESH

PUBLISHED BY
OFFICE OF THE AIRCRAFT ACCIDENT INVESTIGATION COMMITTEE OF BANGLADESH

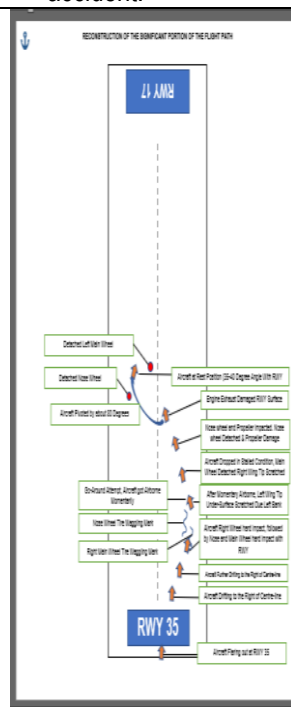
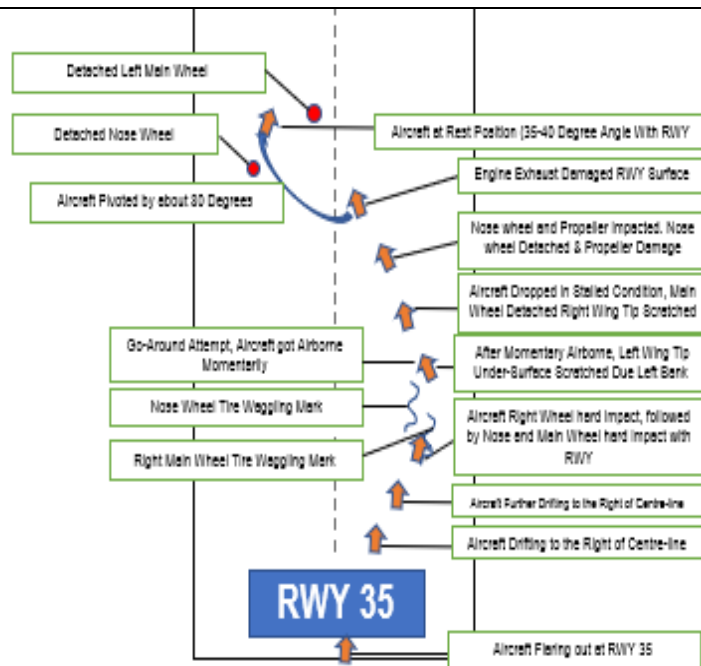
3.1.1.8
Reconstruction of the significant portion of the flight path?

- (g) The aircraft was started around 0835 UTC and got airborne at 0843, initially for a general flying at 1500 feet AGL that included a few 15–45-degree bank turns, stalls etc. After about 15 minutes of aerial works, the SP was instructed by the IP to join the circuit for a Zero-Flap landing at RW 35 followed by a 'Touch & Go'. The SP followed the instruction and attempted the approach and Touch & Go procedure. According to the IP, the SP's final approach was a bit steeper than normal with about 70-75 knots of IAS. The aircraft crossed the Runway threshold at about 55 feet AGL. At this time, as per the IP, the aircraft started drifting to the right when the IP advised the SP to go left towards the centre line. During this process the right main wheel touched heavily on the right half of the runway centre line.

- (h) At this stage, the instructor pilot took over the aircraft control, added full power in an attempt to go around and applied left bank prematurely to move the aircraft towards centre line of the runway. This resulted the aircraft to lift off by about 2-5 feet height momentarily followed by the left-wing tip of the aircraft striking the runway surface and thereby making dents and marks on its under-surface and tip area. Thereafter, the aircraft stalled and fell on the runway surface causing the accident.

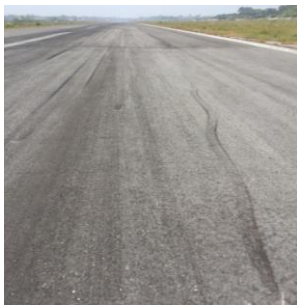
<p>(Figure-1)</p> </div> <div style="text-align: center;">

3.1.12.1 General information on the site of the accident and the distribution pattern of the wreckage, detected material failures or component malfunctions. (Details concerning the location and state of the different pieces of the wreckage are not normally required unless it is necessary to indicate a break-up of the aircraft prior to impact. Diagrams, charts and photographs may be included in this section or attached in the appendices)?	<div style="display: flex;"> <div style="flex: 1;"> <p>(a) The aircraft made the first contact with the runway at approximately 1500 feet down RWY 35 on to the right half of the centre-line at an angle of about 3-4 degrees with the RWY centre-line track (Figure-1).</p> <p>(b) First Touch-Down Tire Marks indicated a partial dislocation of the right wheel after its heavy touch- down. There was no aircraft part or wreckage found in this area (Figure-1).</p> <p>(c) The second impact of the right wheel, when detached, made prominent cut-marks on the runway bitumen as a result of the broken strut that scratched through the runway bitumen. However, there was no aircraft wreckage found in that area (figure-2).</p> <p>(d) On impact of the nose-wheel, the aircraft engine exhaust pipe-edge cut through the runway bitumen that left prominent scar-mark on the runway surface. The detachment of the nose wheel left a broken clamp-part resting 5-7 feet beside the impact area. The impact of the aircraft propeller also left series of cut marks on the bitumen. However, the propeller tips got bent and left no debris in that area (figure-3).</p> </div> <div style="flex: 2;"> <div style="display: flex; justify-content: space-around;"> <div style="text-align: center;">

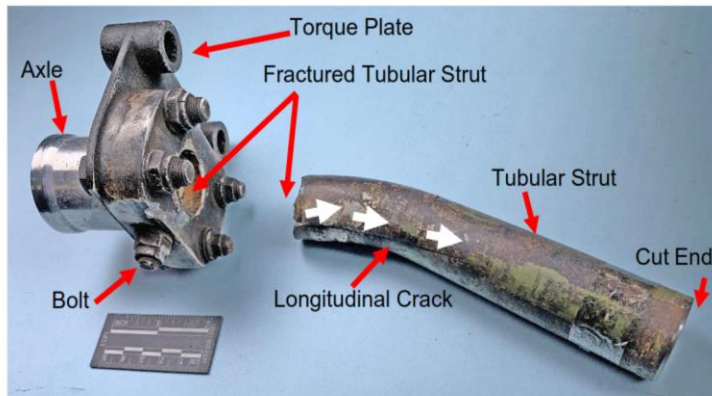
3.1.16.1 Brief statements regarding the results of tests and research?	<p>a) The damaged specimen Spring Assembly-Right Landing Gear Part Number: 0441212-6 was sent to Local NDT (Non-Destructive Test) facility. NDT experts opined that no positive result could be obtained of this damaged specimen as it had already broken in to two pieces.</p> <p>b) On the very first day that is on 10th January 2021 the team looked into the broken area of the damaged specimen through magnifying glass and found that in both broken ends were shining and there was no symptom of dullness in those portions thereof. This means that the spring assembly was broken instantaneously during the second touchdown.</p> <p>c) To find out the root cause of the failure, the AAIT sent the damaged Spring Assembly Landing Gear RH, Pt No. 0441212-6 & AXLE- Main landing gear Attaching Parts, Pt No 0441203-1 for 'Material Test' in the laboratory of National Transportation Safety Board (NTSB), 490L 'Enfant Plaza, SW Washington, DC 20594, USA on 23 January 2022.</p> <p>d) The NTSB carried out the 'Material Test' in the laboratory of National Transportation Safety Board (NTSB) and sent the test report on 31 March 2022. The details of the test report are given below:</p> <p>"As received photographs of the lower portion of the right main landing gear (RMLG) are shown in figures 1 and 2. The RMLG fractured at the lower portion of the tubular strut assembly in the general area of the torque plate. The fracture was oriented generally in the transverse direction. The tubular strut also contained 3-inch longitudinal cracks on diametrically opposite sides that extended from the transverse fracture. These pieces were ultrasonic cleaned with alconox, a detergent that removes iron oxide from ferrous metal. Bench binocular microscope examination of the fracture faces revealed coarse texture fracture on slant planes consistent with overstress separation. The fracture faces showed no evidence of fatigue cracking".</p>

Figure 1. As-received lower portion of the RMLG assembly showing the axle, torque plate for the brake assembly, and mating fractures of the tubular strut (spring assembly). The longitudinal crack propagated in the general direction indicated by white arrows.

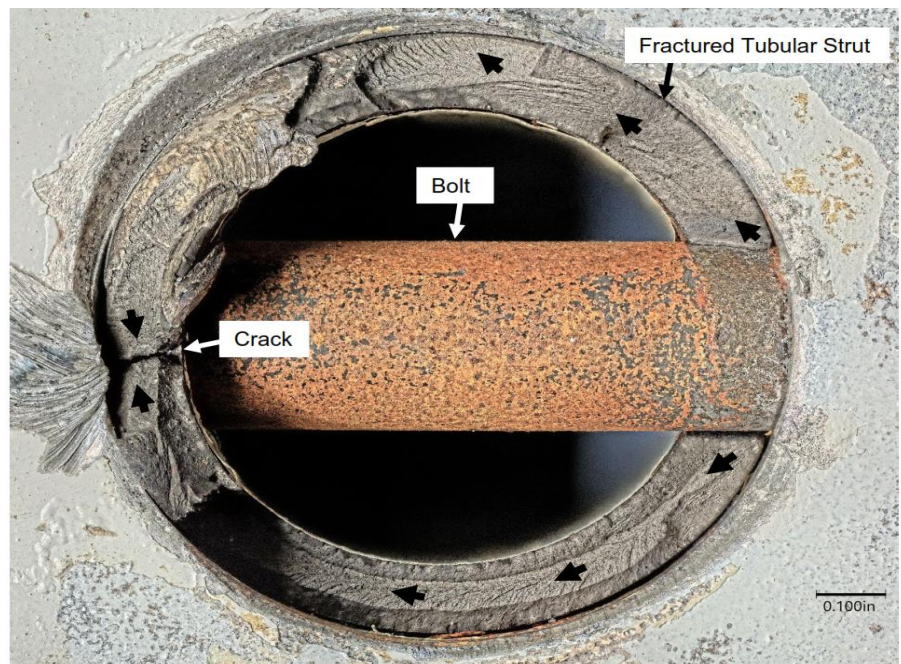
Figure 2. Fracture face of the tubular strut after cleaning with Alconox showing the general direction of fracture propagation (indicated by arrows). This is the fracture face on the side of the axle.
