### FINAL REPORT

INVESTIGATION INTO SERIOUS INCIDENT OF ATR 72-500 AIRCRAFT REG NO S2-AHF  
OF NOVOAIR OCCURRED ON 17 NOVEMBER 2021 AT VGSD AIRPORT,  
SAIDPUR, BANGLADESH

REF. NO. 30.00.0000.013.35.005.21 (ATR 72-500 S2-AHF/ 17 NOV 2021)-141

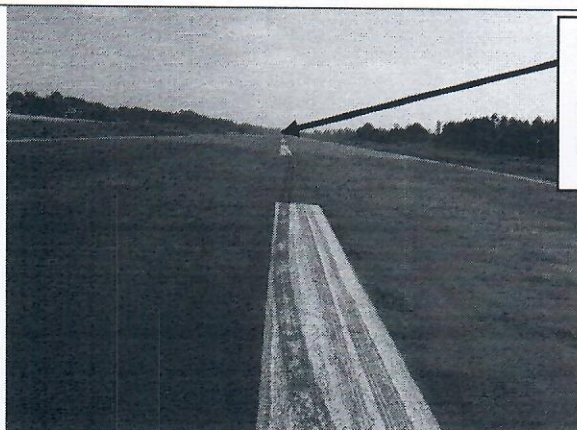
**First  
Touchdown  
point of the  
nose wheel**

First touchdown of nose landing gear.

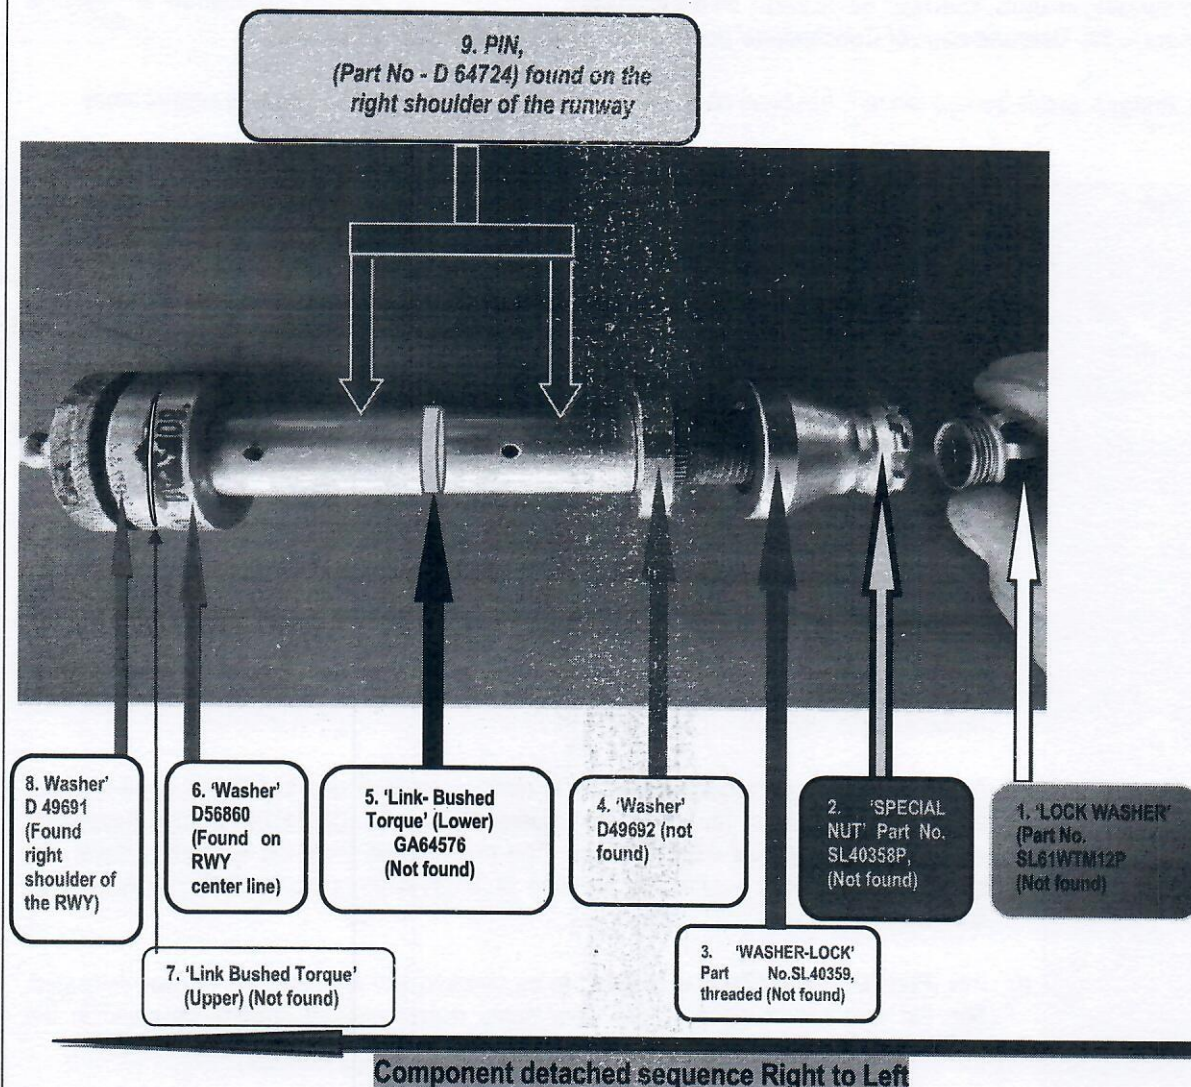
3.1.16.1 Brief statements regarding the results of tests and research	The AAIT intended to find out the probable cause for the separation of the 'PIN' (Part No D64724). Necessary assistance was provided by the manufacturer whereby it was ascertained that 'the thread area of the PIN was corroded. Manufacturer concluded that the <b>corrosion</b> was the main contributor for the disconnection of the Pin.
---	--

3.2.2 Machine	<p>'PIN' (Part No D64724) with 'WASHER' (Part No. D49691) which was found on the right shoulder of the runway is locked by 'LOCK WASHER' (Part No. SL61WTM12P, missing) with 'SEALANT' (Part No. PR1826A2, missing) overlapped. After 'LOCK WASHER' there is a 'SPECIAL NUT' (Part No. SL40358P, missing) which holds the 'PIN'. After the 'SPECIAL NUT' there is a 'WASHER-LOCK' (Part No.SL 40359, missing) which also restricts the movement of 'PIN' and a 'WASHER' (Part No. D49692, missing). After the 'WASHER', the Upper and Lower torque links are installed separated by a 'WASHER' (Part No. D56860, which was found on the center line of the runway).</p>

Full image of the PIN (Part No - D 64724) with its relevant components, including the sequence of detachments of all components, is shown below:

1. 'LOCK WASHER', Part No. SL61WTM12P, -----At first the Lock washer with Sealant went off
2. 'SPECIAL NUT', Part No. SL40358P -----Then the Special Nut opened
3. 'WASHER-LOCK', Part No.SL40359 -----Thirdly the threaded washer opened and went off
4. 'WASHER', Part No. D49692 -----Then one of the washers went off
5. 'Link Bushed Torque' (lower), Part No. GA64576 ----- Unfastened and went off
6. 'WASHER', Part No. D56860 -----Then another washer opened, found center line of the runway
7. 'Link Bushed Torque' (Upper), ----- Unfastened and went off
8. 'WASHER', Part No. D49691 ----- Next Washer opened, found on right shoulder of the runway
9. 'PIN', Part No D64724, (On top) ----- At last the PIN opened, found on right shoulder of the runway

3.3.2 Causes	<p>(a) The main cause of this serious incident was 'Environmental Factor' wherein; eventual loss of median torque link 'PIN' (Part No D64724) due to the corrosion of the thread of the PIN and,</p> <p>(b) Probably the 'Nut' (Part No. SL40358P, not found) causing the loosening of the nut leading to the loss of steering function.</p> <p>(c) Material loss due to corrosion was responsible for thread contour failing. This failing results in increased load on the remaining threads leading to their deformation and allowing the nut to become detached from the PIN.</p>

3.4.2 Safety Recommendations	<p><b>NOVOAIR and all other ATR Air Operators (Pax and Cargo) of Bangladesh should:</b></p> <p>(a) Take appropriate environmental protection and anti-corrosive measures to prevent decay of the thread area of the NLG PIN of ATR aircraft.</p> <p>(b) Perform repetitive inspection of the NLG PIN in accordance with the instructions of SLS VSB (Vendor Service Bulletin) 631-32-221 Rev 3 and OIM (Operators Information Message) 2022/008 issue 1.</p> <p>(c) Firmly adhere to the instructions of SB (Service Bulletin) and OIM (Operators Information Message) iro NLG of ATR aircraft.</p>
