PRELIMINARY REPORT

INVESTIGATION INTO SERIOUS INCIDENT OF ATR 42-300 AIRCRAFT, REG NO. S2-AHI OF NXT AIR LTD, OCCURRED ON 05 JUNE 2022 AT VGEG AIRPORT, CHATTOGRAM, BANGLADESH

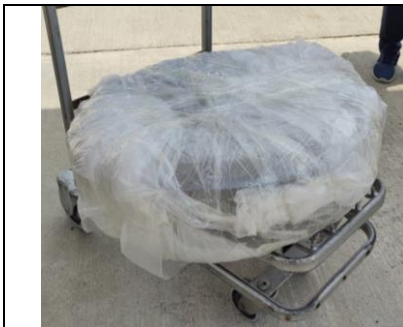
<p>Figure-1: Detached wheel assembly in packed condition.</p> </div> <div style="text-align: center;">

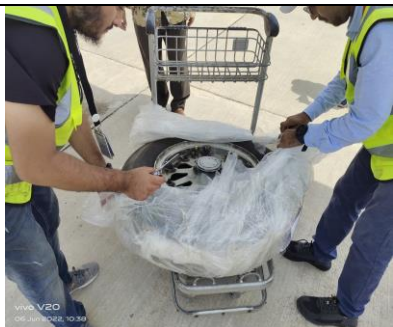
<p>Figure-1: Un-packing the wheel in front of 'Go-Team'</p> </div> </div>

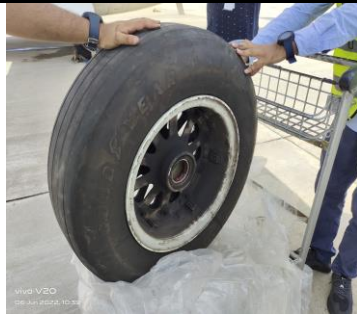
- (a) Left wheel assembly PT No. PN 5006856-5R S/N: OCT89-96 was found damaged.
- (b) Hub Locking Bolt PN: AN3H5A (Qty 02) was found broken into two pieces. The upper part of both the locking bolts were attached with the locking wire with the wheel assembly, the lower part of both the bolts were attached with wheel axle till the tip of the thread on the other end.
- (c) Roller Bearing, Cone Assembly PN: L610549 (Outer Bearing Roller Cone) was found damage; 8 rollers came out from inside; Traces of corrosion was found in the roler and in the housing of bearing.
- (d) Scratch marks were found on the shinning portion of the left wheel axle PT No. D57259-2., Which was observed throught out the shinning part circumferatially.

Figure-3: Inner side of the damaged wheel assembly.

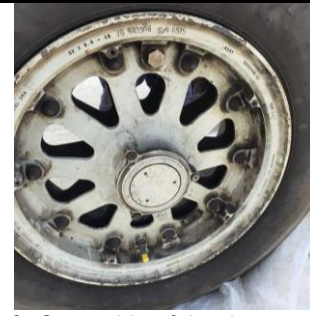
Figure-3: Outer side of the damaged wheel assembly.

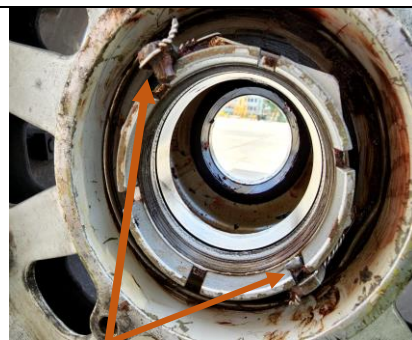
1. Locking bolt PT No. AN3H5A (Quantity 2) got broken/sheared off into two pieces. The upper part of both the locking bolts were attached with locking wire with the axle nut of the wheel assembly.

Figure-5: Upper part of the locking bolt attached with the locking wire of the wheel assembly

3.4.1.1 Intermediary Safety Recommendations	<p>(a) One time inspection is to be carried out to check the condition, specially the presence of corrosion, crack or any other abnormality to all bearings (inner and outer and hub locking bolts in both main and nose landing gear wheel assemblies and necessary preventive action is to be taken as necessary. This is applicable to all operators of Bangladesh using ATR aircraft in their fleets.</p> <p>(b) The aircraft operating at Cox's Bazar are more susceptible to corrosion due to salinity. As such a preventive corrosion control program, if not already included in the corrosion preventive program in the aircraft maintenance schedule, may be introduced in the Aircraft Maintenance Programme (AMP) as a measure to prevent corrosion. This is applicable to all aircraft operating in Cox's bazar,.</p>
---	--

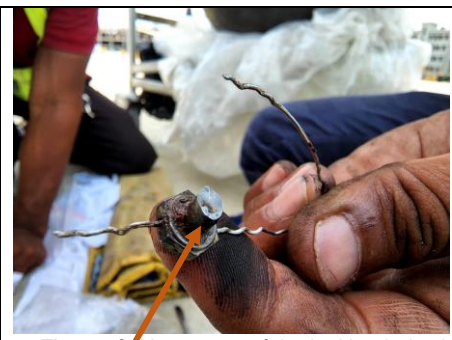
Figure -6: Upper part of the locking bolt with locking wire after removal from the wheel assembly.

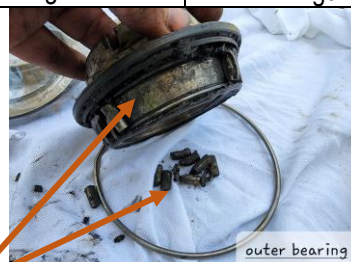
(d) The outer bearing cone assembly PN. L610549 was found damaged, the outer race of the bearing got broken and 8 rollers came out from inside. Found traces of corrosion in rollers and housing of the bearing.

Figure-9: Traces of corrosion of roller and bearing.

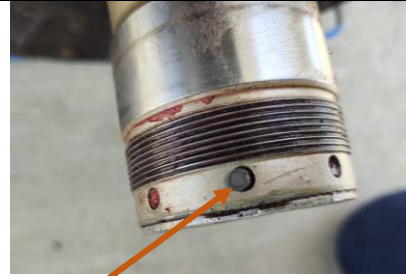
(e) The team inspected the No.1 left wheel axle PT. No. D57259-2; found lower part of sheared off locking bolts were attached with the axle till the tip of the thread to the other end.

Figure-10: Lower part of the shearing locking bolt attached to wheel axle (Upper View)

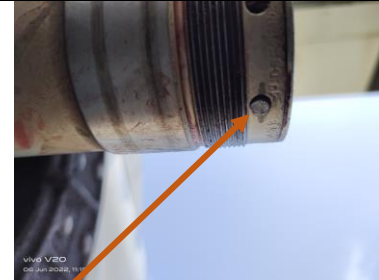
Figure-11: Lower part of the shearing locking bolt attached to wheel axle (Lower View)

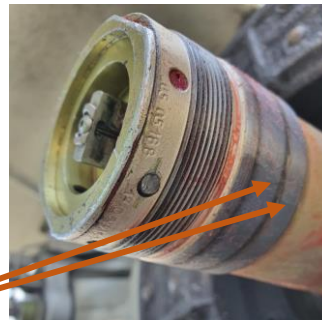
(f) Scratch marks were found on the shinning portion of the axle which was observed through out the shinning part circumferentially.

Figure-12: Scratch marks on the shinning portion of the axle through out the shinning part circumferentially
