FINAL REPORT

INVESTIGATION INTO THE INCIDENT OF BOEING 737-800 AIRCRAFT REGISTRATION NUMBER S2-AJA OF US BANGLA AIRLINES LTD THAT OCCURRED ON 02 JANUARY 2024 AT VGSY AIRPORT, SYLHET, BANGLADESH

REF. NO. 30.00.0000.013.34.002.22 (B 737-800 S2-AJA/ 02 JANUARY 2024)-191

DATE OF RELEASE: 01 JANUARY 2025

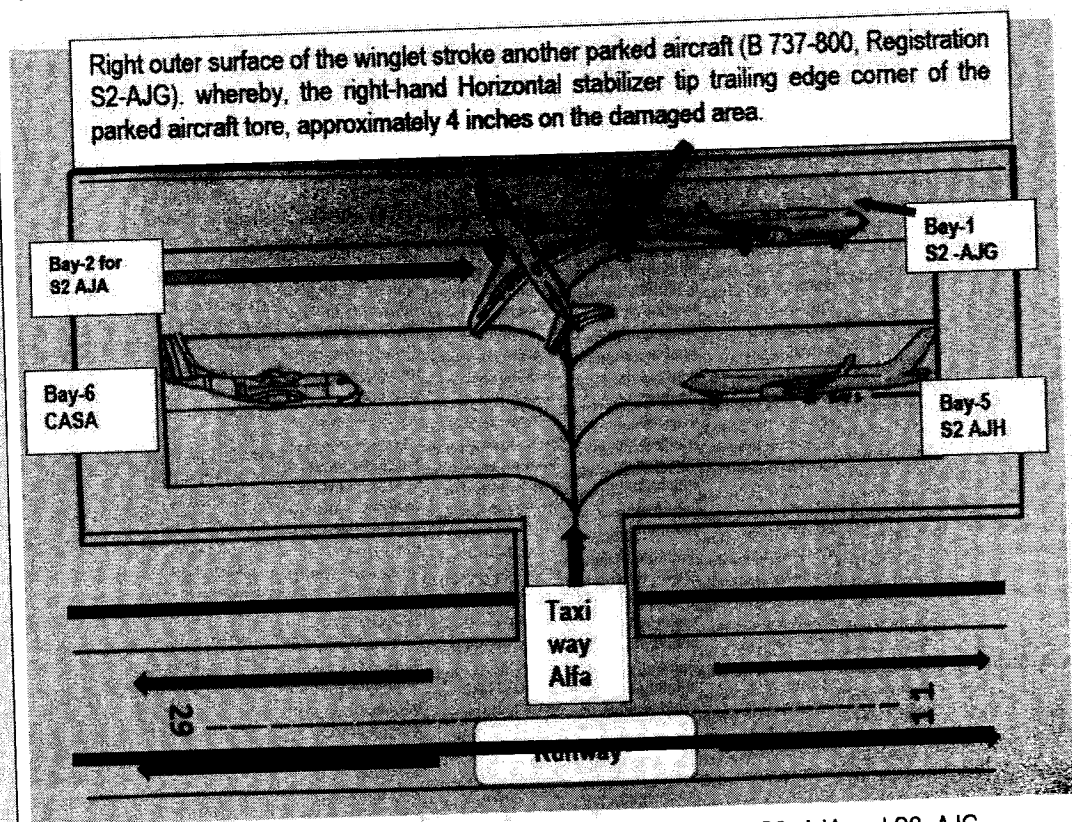
On 01 January 2024, the B 737 (Reg No- S2 AJA), aircraft took off from Guangzhou Baiyun International Airport for VGHS. On 02 January 2024, due to poor visibility at VGHS, Dhaka, the aircraft diverted to Osmani International Airport, Sylhet and landed safely at 0207 hrs UTC. After landing, as per the instruction of the Air traffic controller, the pilot was taxiing to parking stand Bay-2. At parking stand Bay-1, another aircraft, Reg No- S2 AJG was parked before. This aircraft (Reg No- S2 AJG) was parked 34 ft short of parking stand Bay 1. During taxiing to parking stand Bay- 2, as the aircraft turned left for its parking stand, the right winglet of the taxiing aircraft struck the right-hand horizontal stabilizer tip trailing edge corner of the parked aircraft (Reg No- S2 AJG).

Figure- 1 Ground Incident (Collision) between Boeing 737, S2- AJA and S2- AJG

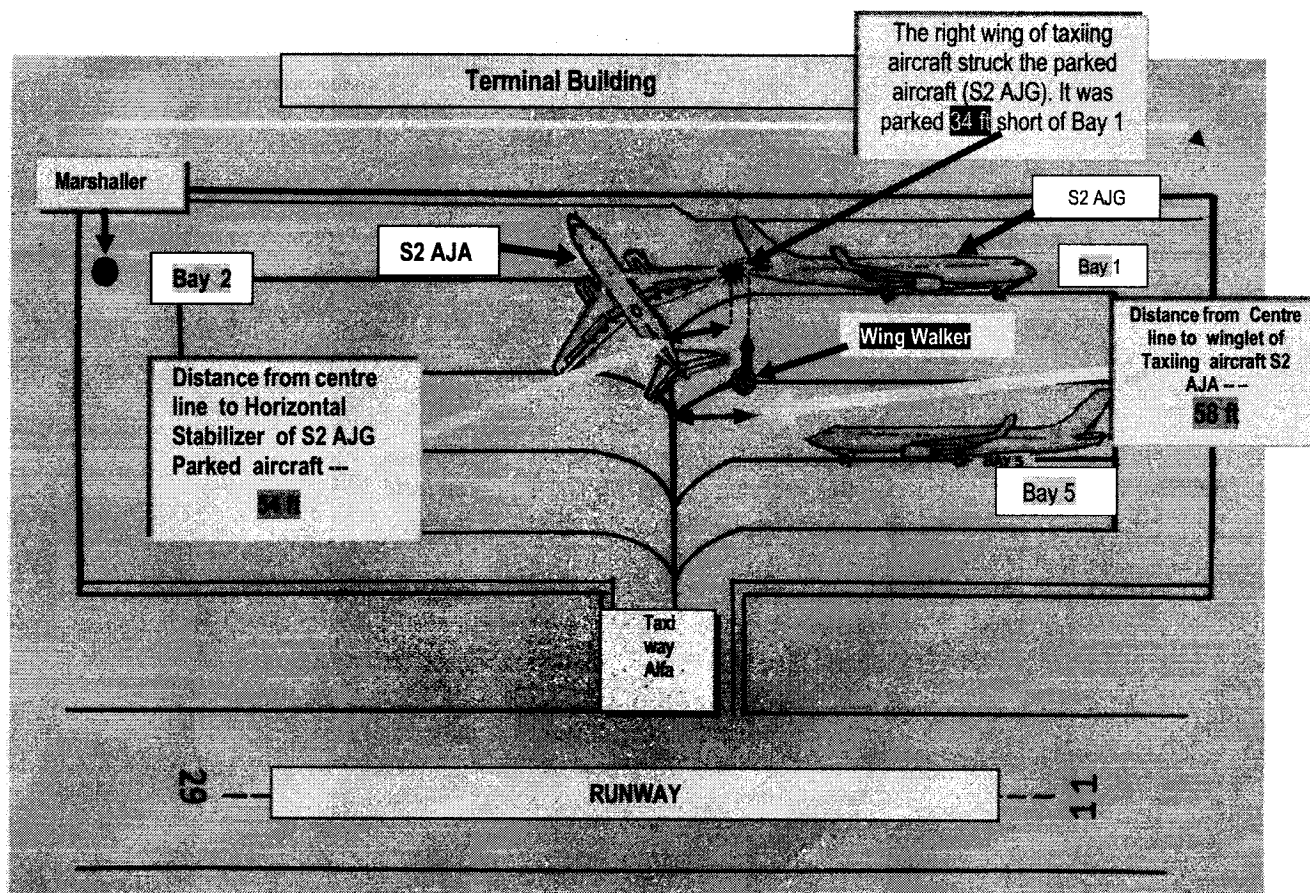
Figure- 2 Diagram for 'Root Cause' of the Ground Incident (Collision)

The wing walker, during questioning, revealed that the incumbent did not have any clue about hand signaling and giving wing-clearance to aircraft. He, being a person from the Customer Service of the Air Operator, was not trained to perform this type of job. He walked along the taxiing aircraft and was not able to visualize the horizontal distance between the taxiing aircraft and the parked aircraft. (**Figure -2**).

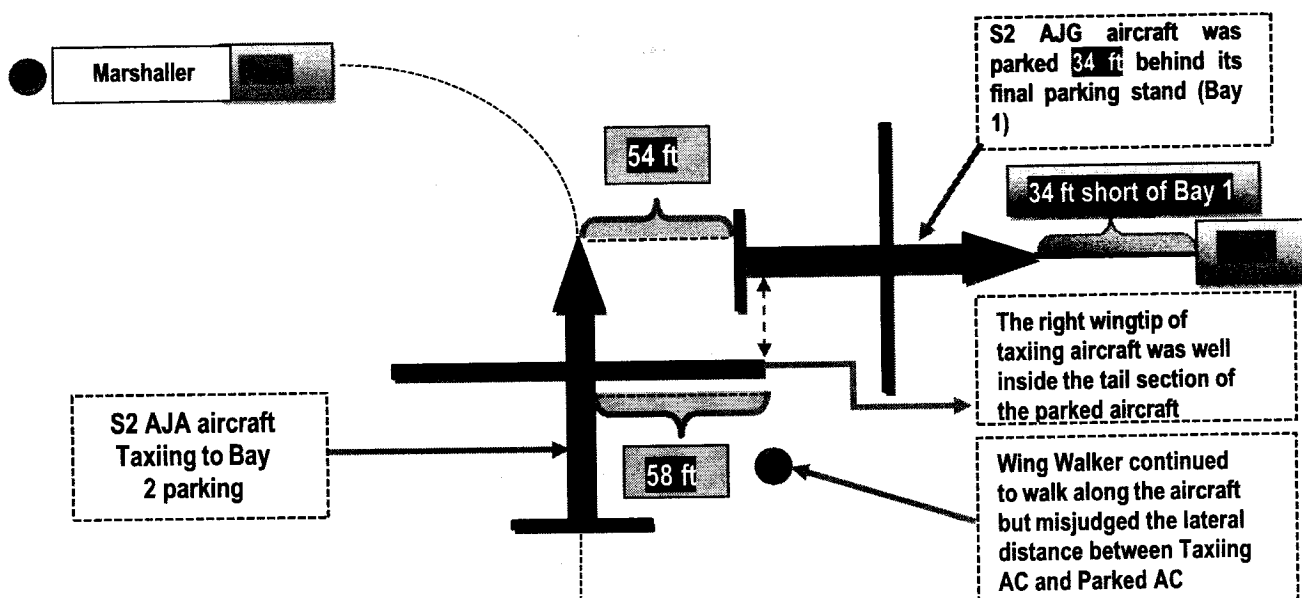
Figure -3 Sketch diagram of ground Incident (Collision)

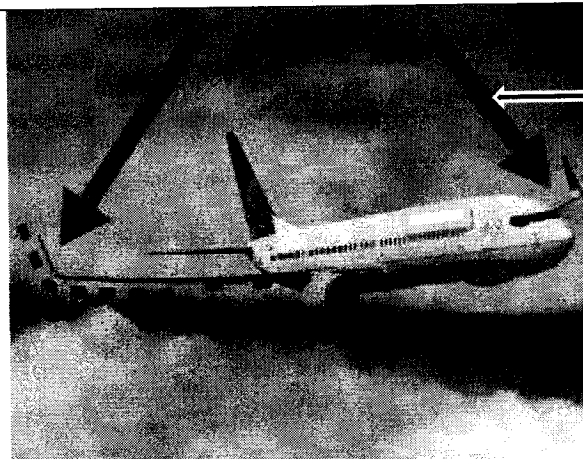
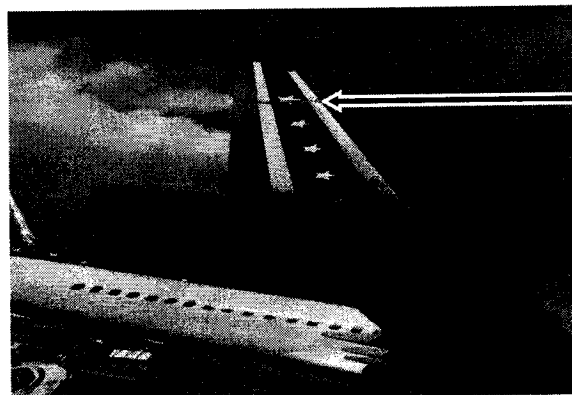
Figure - 4 Winglet and Damaged Right winglet

3.1.3.1 Destroyed	No
3.1.3.2 Substantially damaged	(a) With regard to taxiing aircraft S2-AJA, the RH winglet outer surface was found torn by 15 inches long split; and. (b) With Regard to parked aircraft S2-AJG, the RH Horizontal stabilizer trailing edge tip was damaged and torn off, 4 inches on the damaged area.
3.1.3.3 Slightly damaged	NIL

Red arrow mark shows Winglet of aircraft

Damaged Right winglet of B 737 Reg - S2 AJA
