FINAL REPORT

INVESTIGATION INTO INCIDENT OF DHC-8 SERIES-400 AIRCRAFT REG NO S2-AJW
OF BIMAN BANGLADESH AIRLINES OCCURRED ON 16 MAY 2025 AT VGCB, COX'S BAZAR AIRPORT
BANGLADESH.

**PUBLISHED BY
THE OFFICE OF THE AIRCRAFT ACCIDENT AND SERIOUS INCIDENT INVESTIGATION COMMITTEE OF
BANGLADESH**

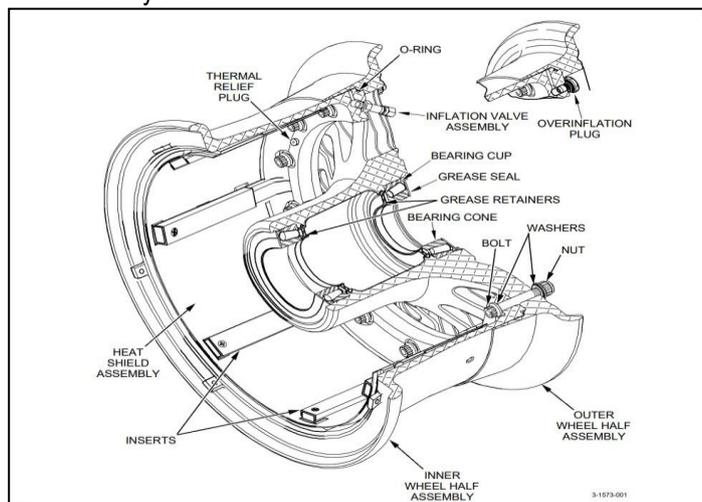
Figure 1: Main Wheel – Cross section

- (a) The OEM carried out the inspection of the subject axle, studied the photographs of the wheel, tire and axle and send the report to AAIT on 21 January 2026. The followings are the salient points of the report as mentioned below.
 - a. Below are the Main Wheel Cross section and photographs received by the OEM.
