REF. NO. 30.00.0000.013.33.001.25/27 (Airbus A330-300 Reg HS-TEW / 29 Oct 2025)

DATE OF RELEASE: 20 November 2025

## PRELIMINARY REPORT

### INVESTIGATION INTO SERIOUS INCIDENT OF AIRBUS A330-300 AIRCRAFT, REG NO HS-TEW OF THAI AIRWAYS INTERNATIONAL OCCURRED ON 29 OCTOBER 2025 AT VGHS, DHAKA, BANGLADESH

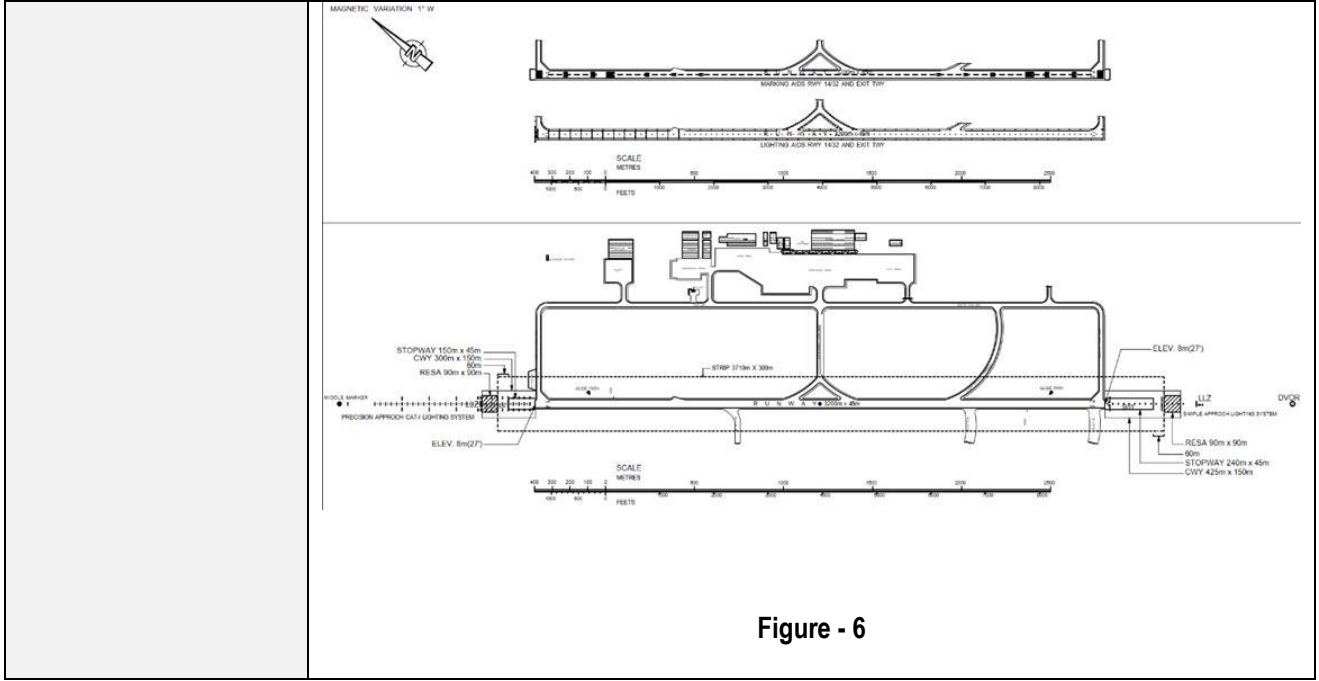
3.1.10.1 Pertinent information associated with the aerodrome, facilities and condition, or with the take-off or landing area if other than an aerodrome	<b>General:</b>  Aerodrome facilities and associated conditions were normal. However, the runway surface was wet due to medium to heavy rain.  Hazrat Shahjalal International Airport (VGHS) coordinates Latitude- 235118.08 N and Longitude- 0902318.67 E is located. The airport has an elevation of 26 ft.
---	---
