PRELIMINARY REPORT

INVESTIGATION INTO ACCIDENT OF CESSNA-152 AIRCRAFT REG NO S2-AFK
OF GALAXY FLYING ACADEMY LTD OCCURRED ON 09 JANUARY 2021
AT VGRJ AIRPORT, RAJSHAHI, BANGLADESH.

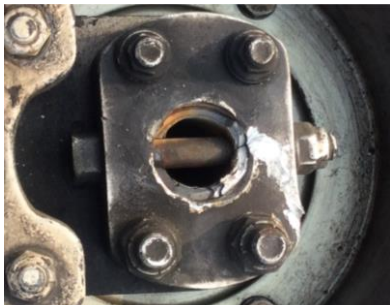
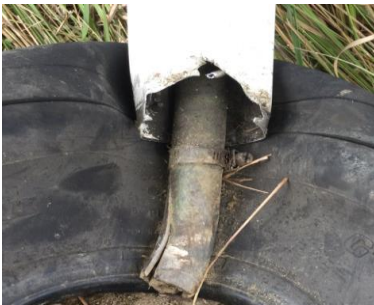
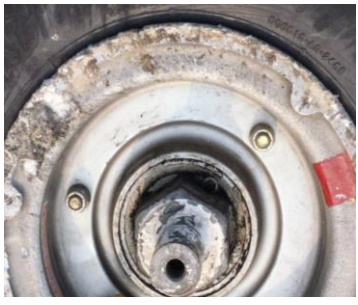
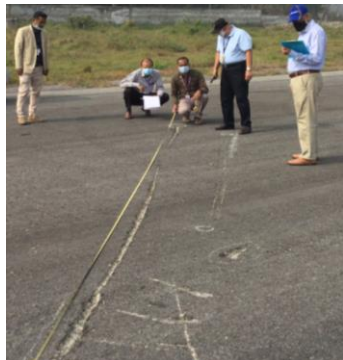
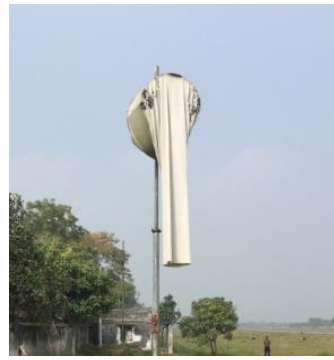
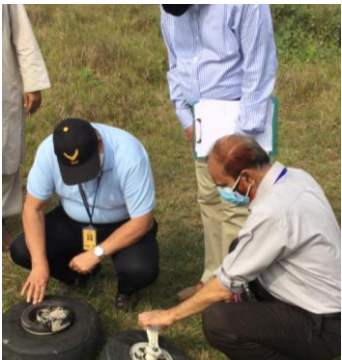
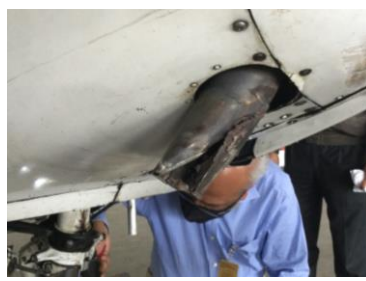
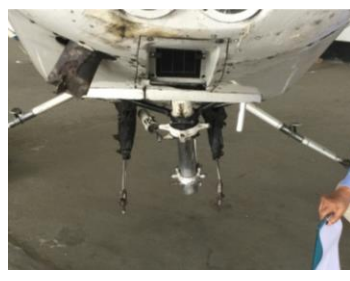
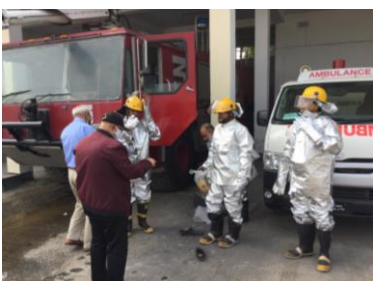
3.17.2 Photos:

(i) Soon after airborne, the aircraft came down in a stalled condition on the runway, close to the centre-line with an angle of about 3-5 degrees into the runway centre-line. At this stage, the right main landing wheel impacted heavily on the runway surface, a second time, and sheared-off from its strut-assembly, getting detached from the aircraft.

(j) During the detachment of the right wheel, the right-wing tip as well as portion of the right elevator tip (under surface) of the aircraft also received scratch mark from the runway surface. The detached wheel, subsequently made significant damage to the aircraft right fuselage as well as the right elevator. The broken strut-edge of the right wheel made about 10-feet-long x 1-inch-deep scar mark on the runway bitumen. The dislodged right wheel finally rested about 20 feet ahead of the place where the disabled aircraft rested that pivoted around the broken strut and stopped at the western half of the runway centre-line at an angle of about 45 degrees with the runway track, facing 'North-east'.

(l) Both Tips of the engine propeller were found bent to a large extent, the nose cowling area received structural damage and the detached nose wheel rested about 15-20 feet behind the disabled aircraft. The sharp edges of the exposed engine-exhaust pipe dragged the runway surface making roughly 2-feet-long x 1.5-inch-deep cut mark on the runway bitumen.

3.3.4 Other damage? (Damage to Runway)	<ul style="list-style-type: none"> (a) Wagging tire marks on runway surface, resulted from aircraft initial touch-down; (b) About 10-feet-long x 1-inch-deep bitumen cut-mark on runway surface, resulted following the right wheel detachment; (c) About 2-feet-long x 1.5-inch-deep bitumen cut mark on runway surface, resulted following the nose wheel detachment and friction by the aircraft engine's exhaust pipe; (d) Several prominent bitumen cut-marks on runway surface due to propeller hits; (e) Aircraft wing scratch-mark of right-wing tip area, right elevator tip area and left-wing tip area on the runway surface.
---	---
