Final Report

Investigation into the Accident of Robinson R-66 Helicopter, Nationality and Registration Mark S2-AIB of Meghna Aviation Ltd (MAL) on 16 September 2016 At Inani Beach, Cox's Bazar, Bangladesh

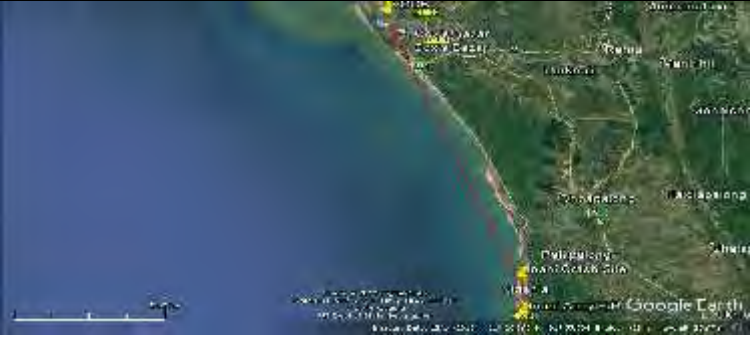
3.1.7 Reconstruction of the significant portion of the flight path

Inani, Cox's Bazar and Crash Site Area
3.1.8 Location (latitude, longitude, elevation),	N21°13.601' E092 ° 2.875'; Elevation: 03 Feet
